Penn State
Harrisburg
The Capital College

Campus Exterior Architectural Plan
November 2006

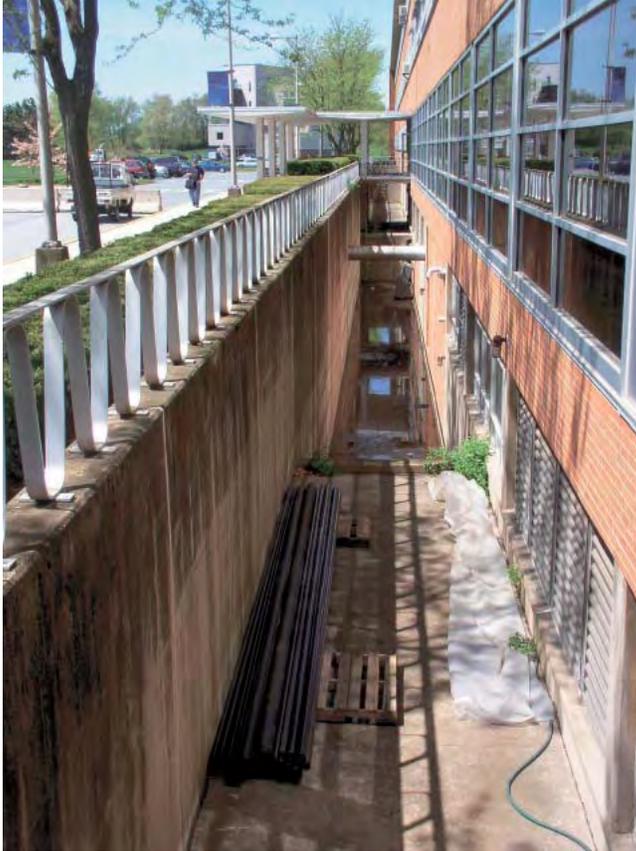
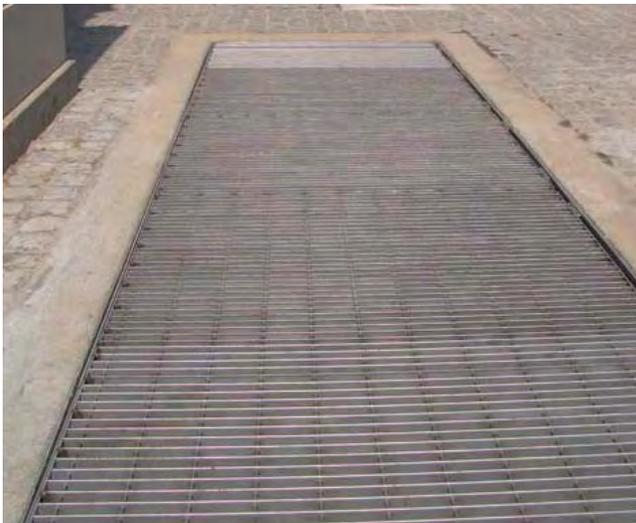
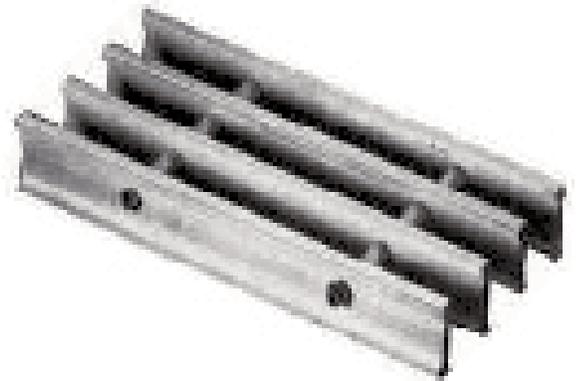
Olmsted Areaway ^{1A}

The areaway to the basement on the south side of Olmsted Building should be covered for safety and aesthetic reasons. It is recommended that aluminum bar grate that permits the circulation of air yet obscures views be installed.

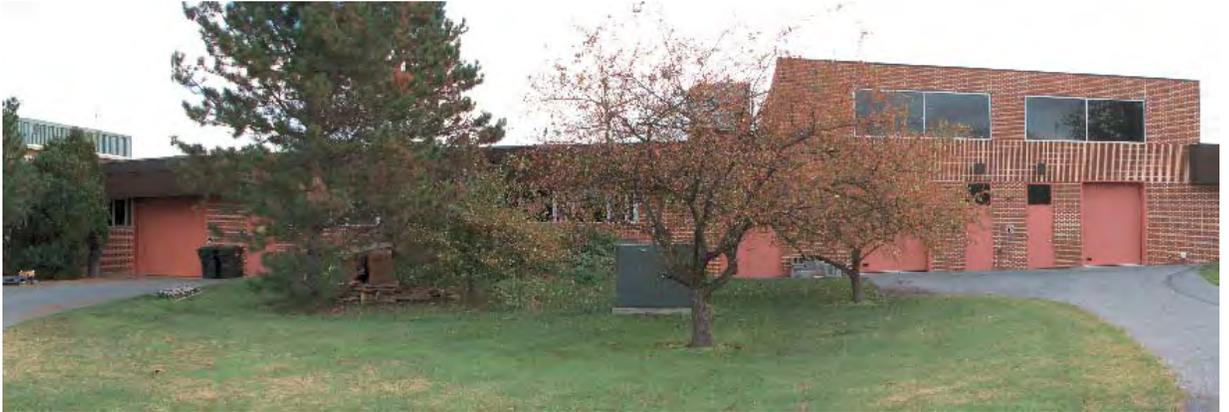
1B

Color of painted exterior doors should be consistent with other trim elements on the building.

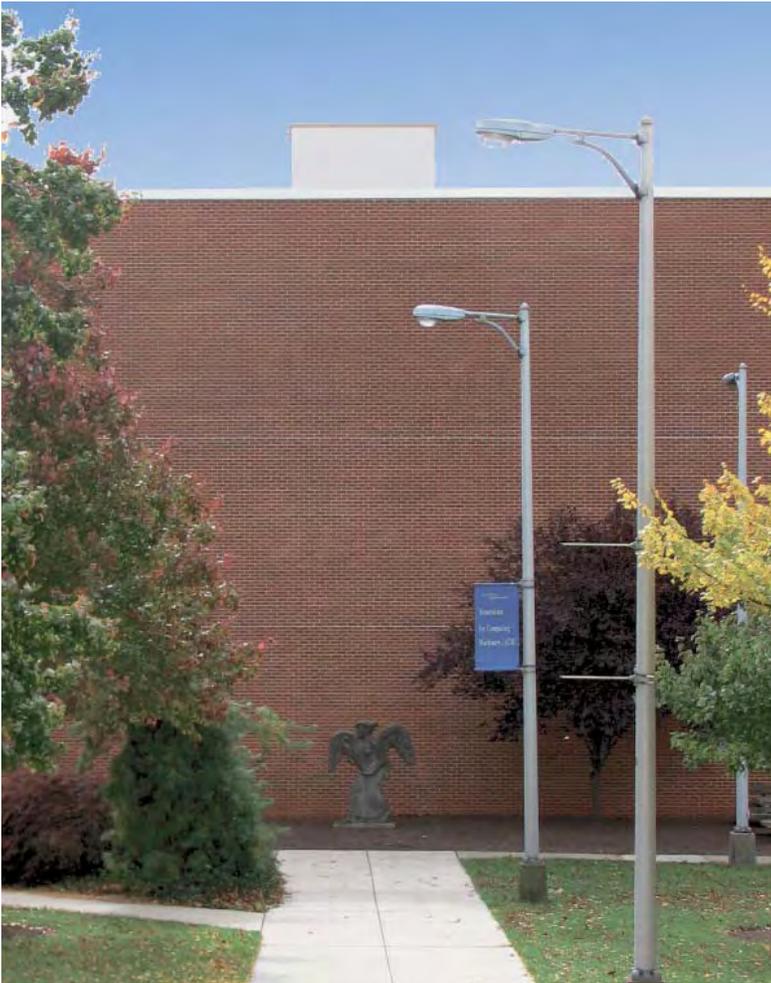
1c Paint Penthouse

It is recommended that the campus be vigilant about maintaining painted surfaces.

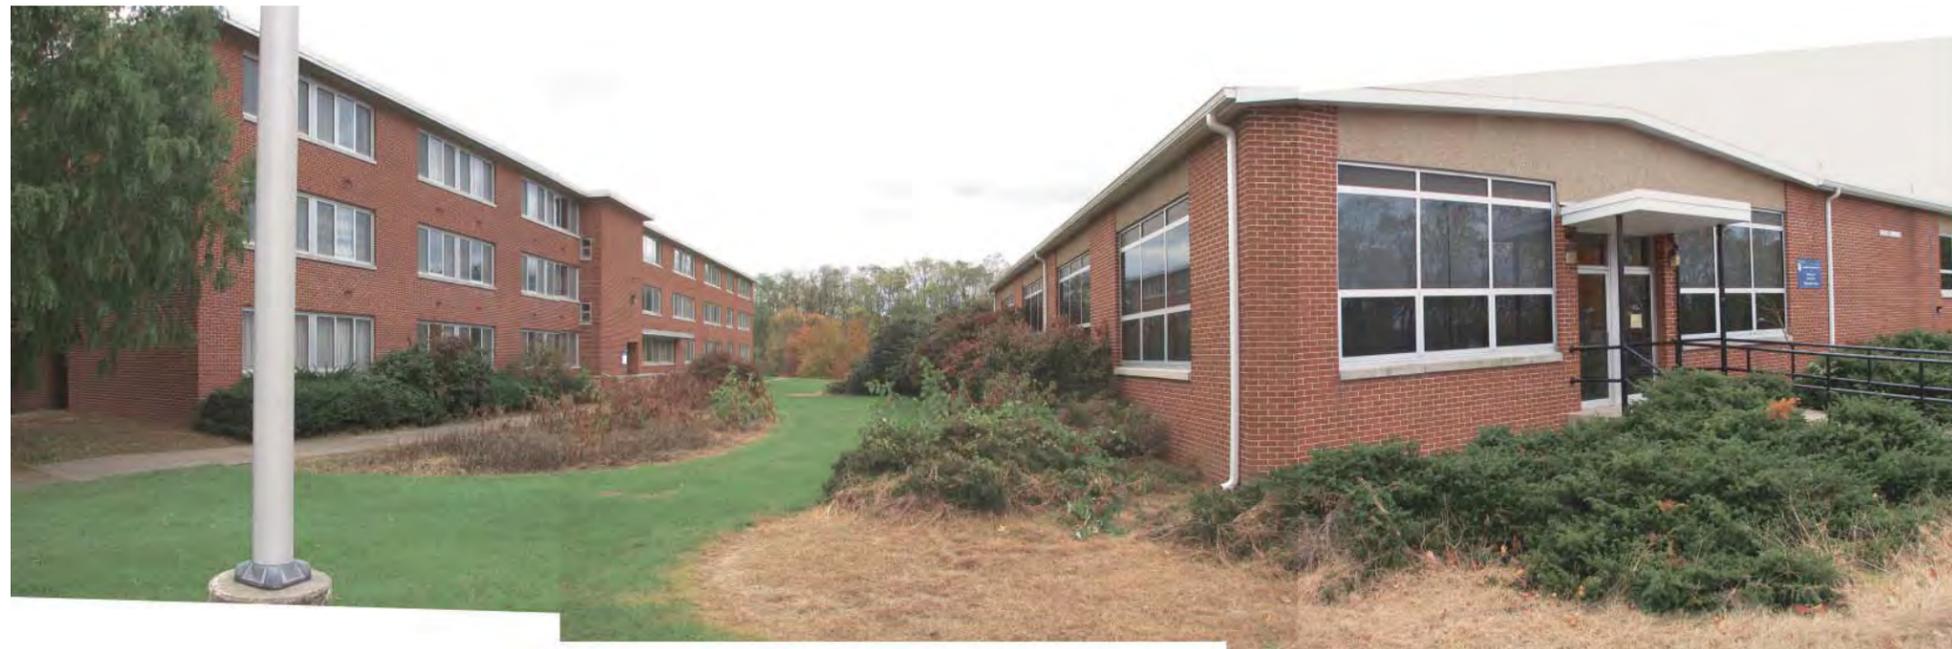
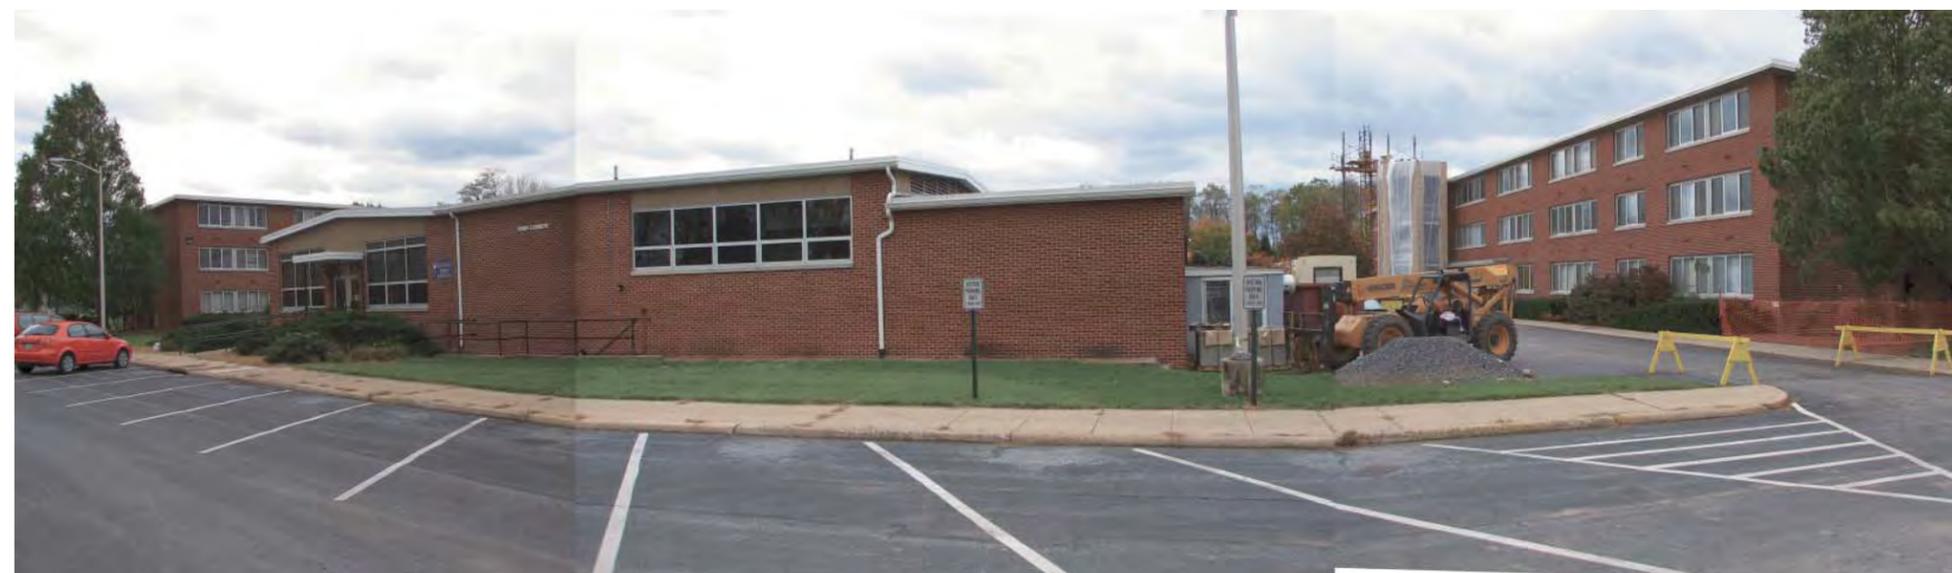
1D Church/Wrisberg/Dining Halls

The landscape and buildings in this area impart a feeling of abandonment and neglect. While in transition to other uses, the landscape surrounding these buildings requires routine maintenance such as weed control, pruning and mulching. Glass in the door to the dining hall is broken. Stored materials inside are visible from the exterior. Dining Hall signage on the building should be removed. Railings and fire escape stair towers require painting.

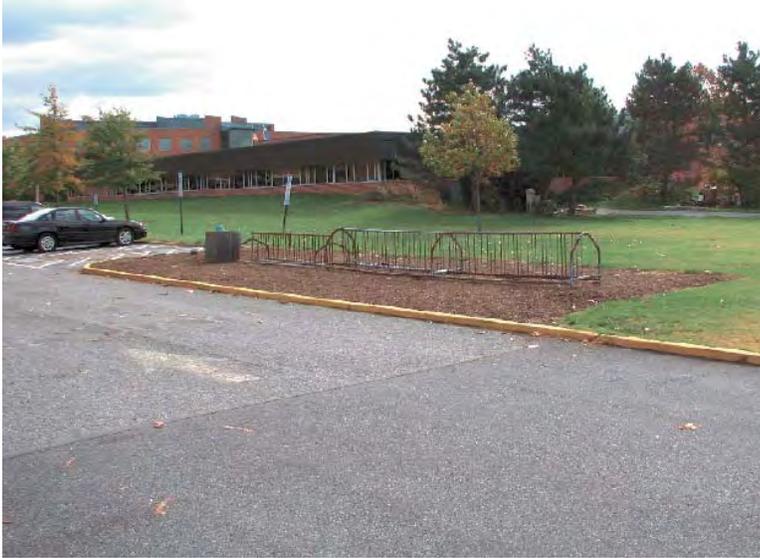
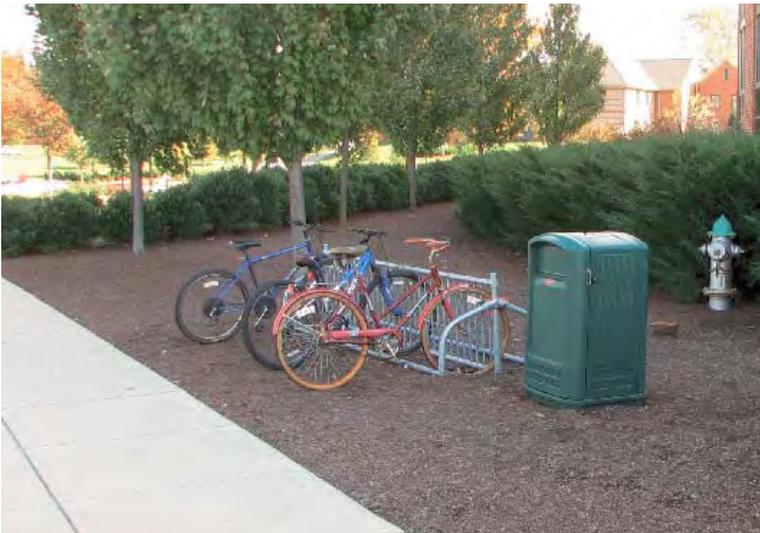
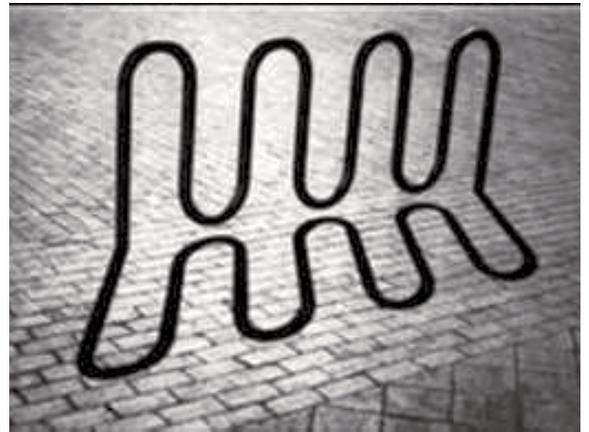
2B Bike Racks

An assessment by the campus should be undertaken to determine the need for bike racks. Rack locations should be convenient to users while minimizing pedestrian and vehicular conflicts. Consolidation of racks into a courtyard(s) with perimeter screening and paved surface is recommended.

Replace rusted and deteriorated units with a new campus standard such as the example shown below.

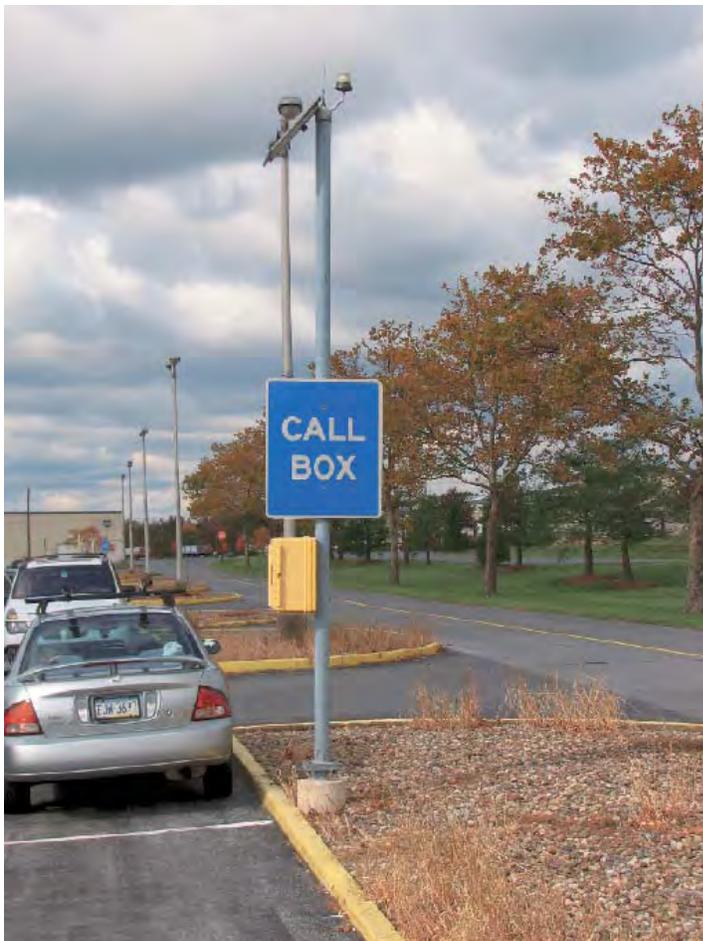
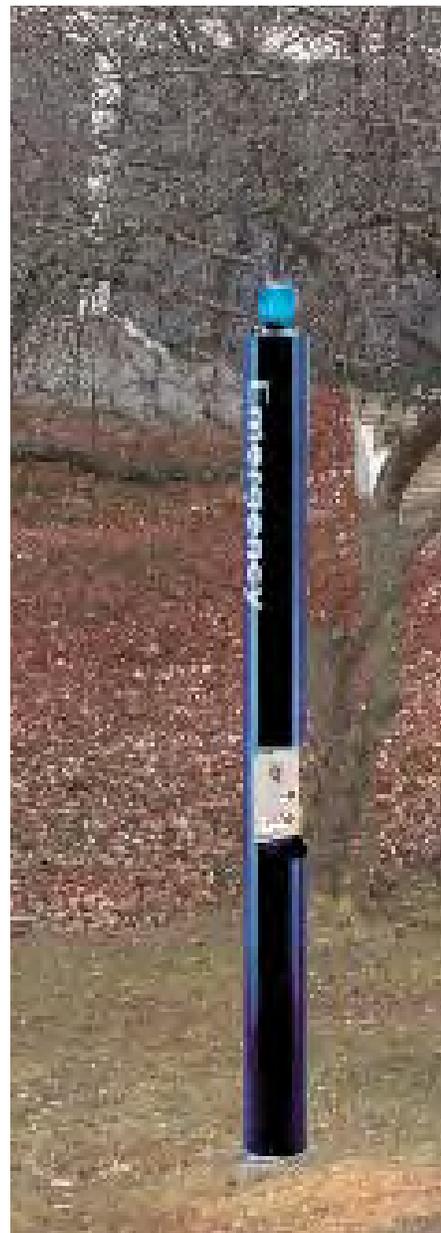
2c Emergency Phones

A few isolated instances of the old emergency call boxes are noted on campus. It is recommended that the transition of emergency phones to Code Blue® model be completed.

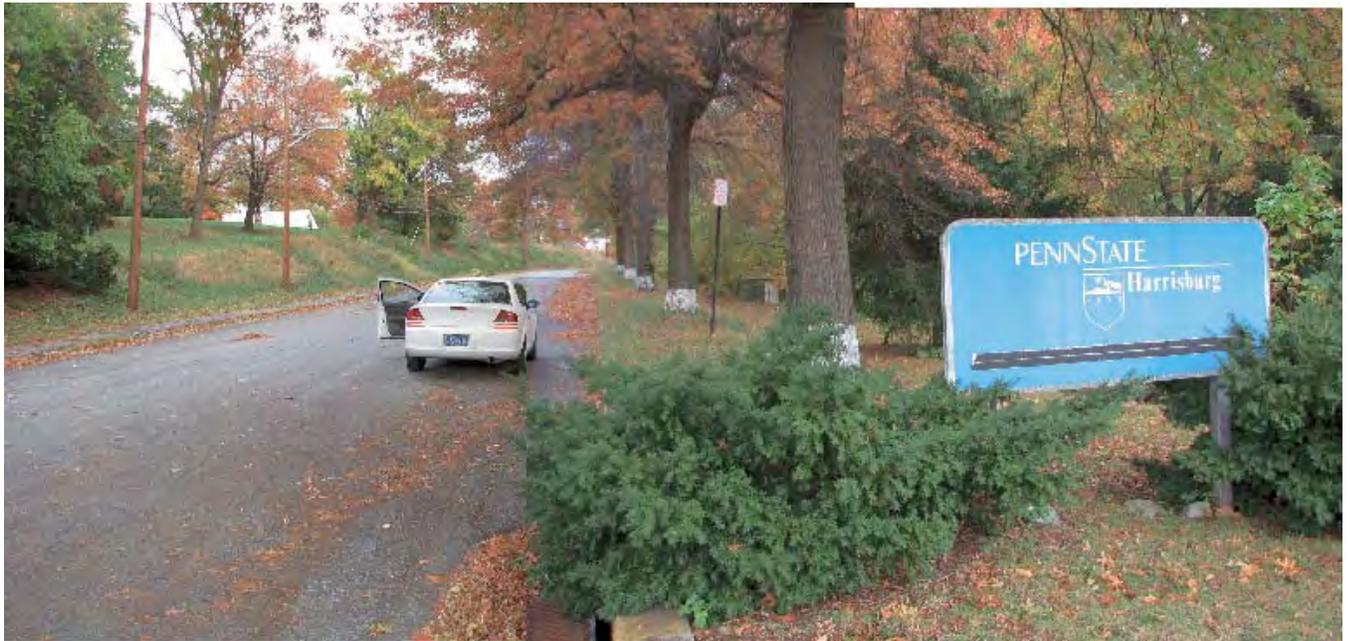
4B Sign Removal

Remove existing obsolete sign identifying Mead Heights. Relocate barrier gates to intersection with Rosedale Avenue.

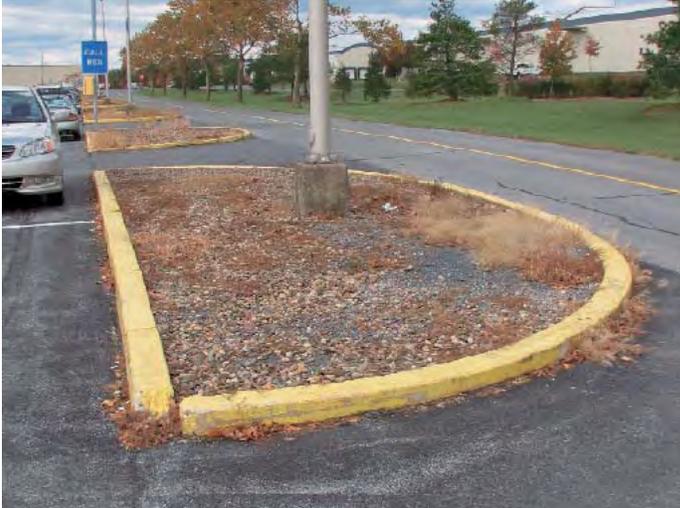
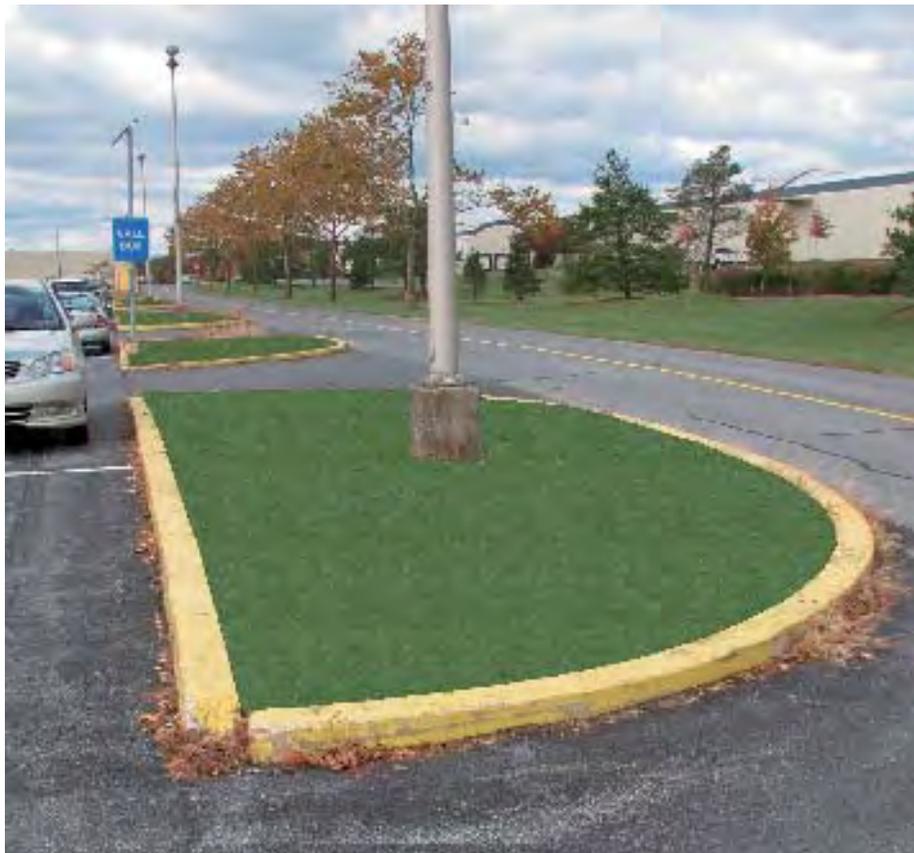
5A

Replace gravel groundcover in parking lot islands with turf. Unless mandated by a regulatory code, the painting of curbs is discouraged. Not only is such a practice added maintenance but it draws undue attention to a utilitarian feature.

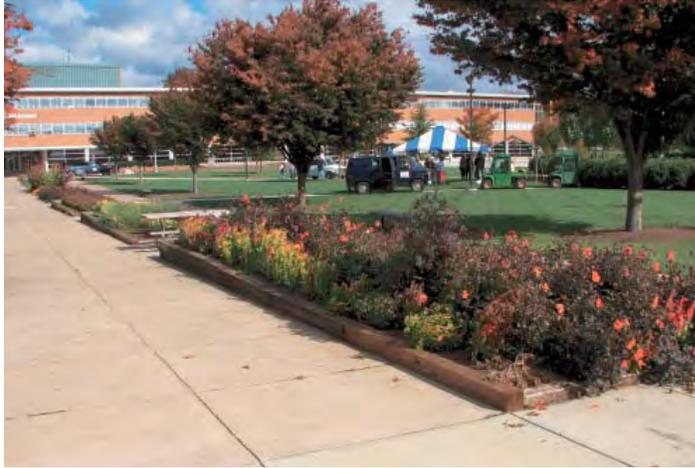
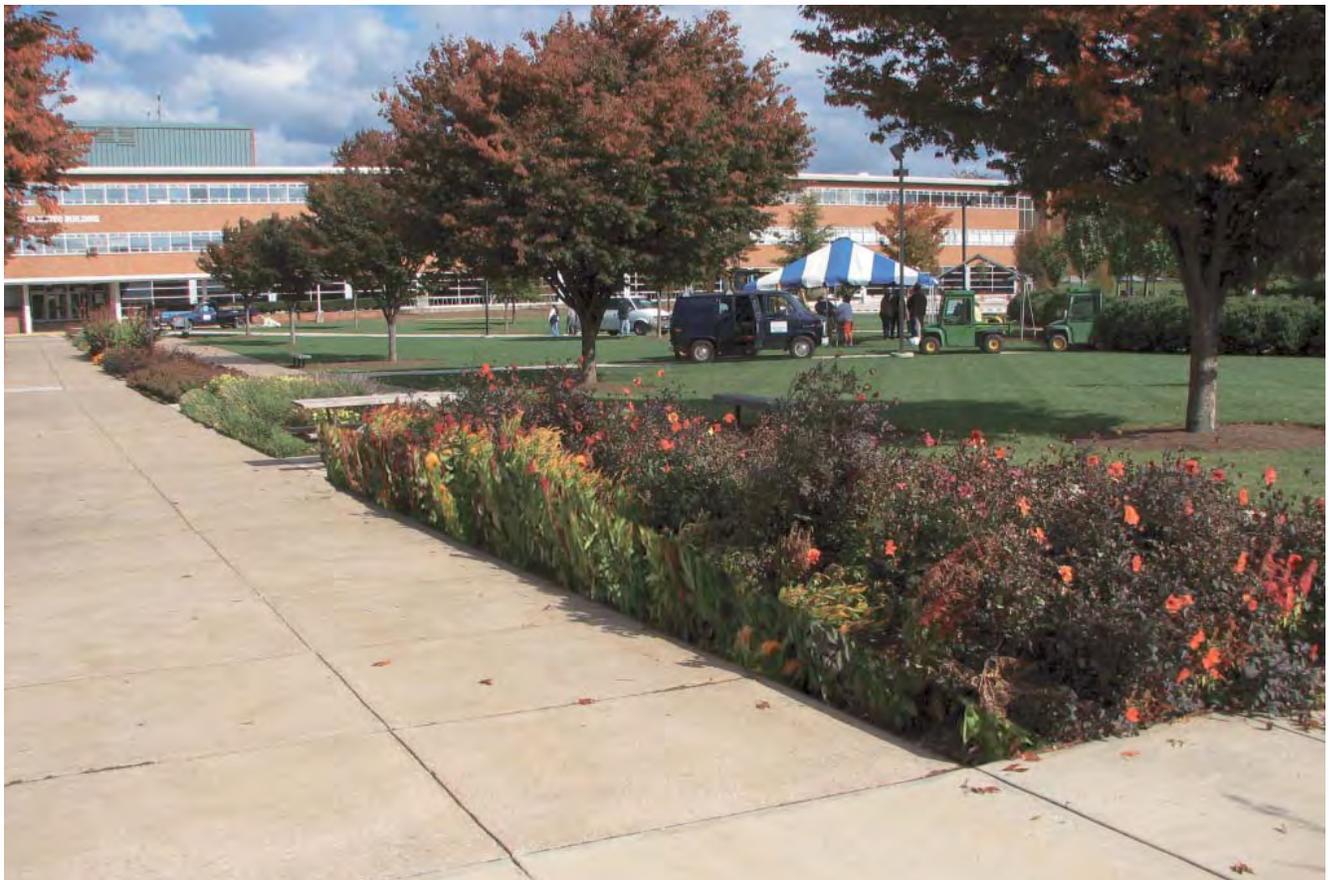
5B Landscape Timbers

Planting beds edged with wood timbers impart a residential aesthetic and should be avoided in major pedestrian areas. Recommend the removal of this type of bed edging on the Vartan plaza in the heart of campus.

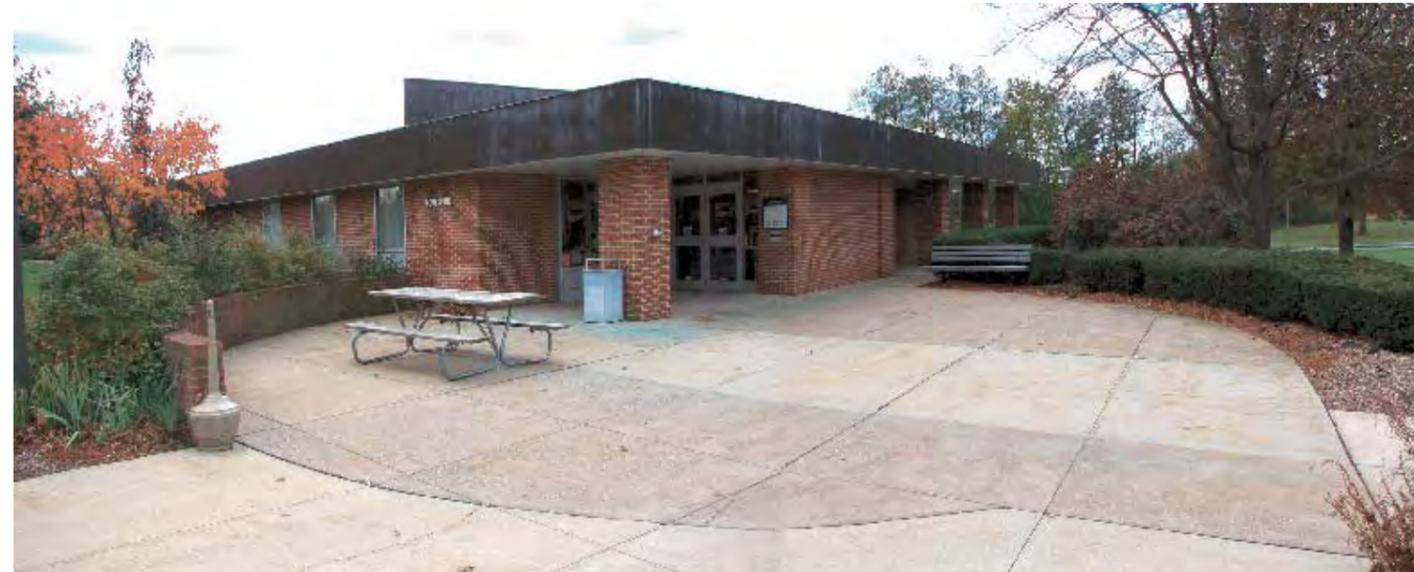
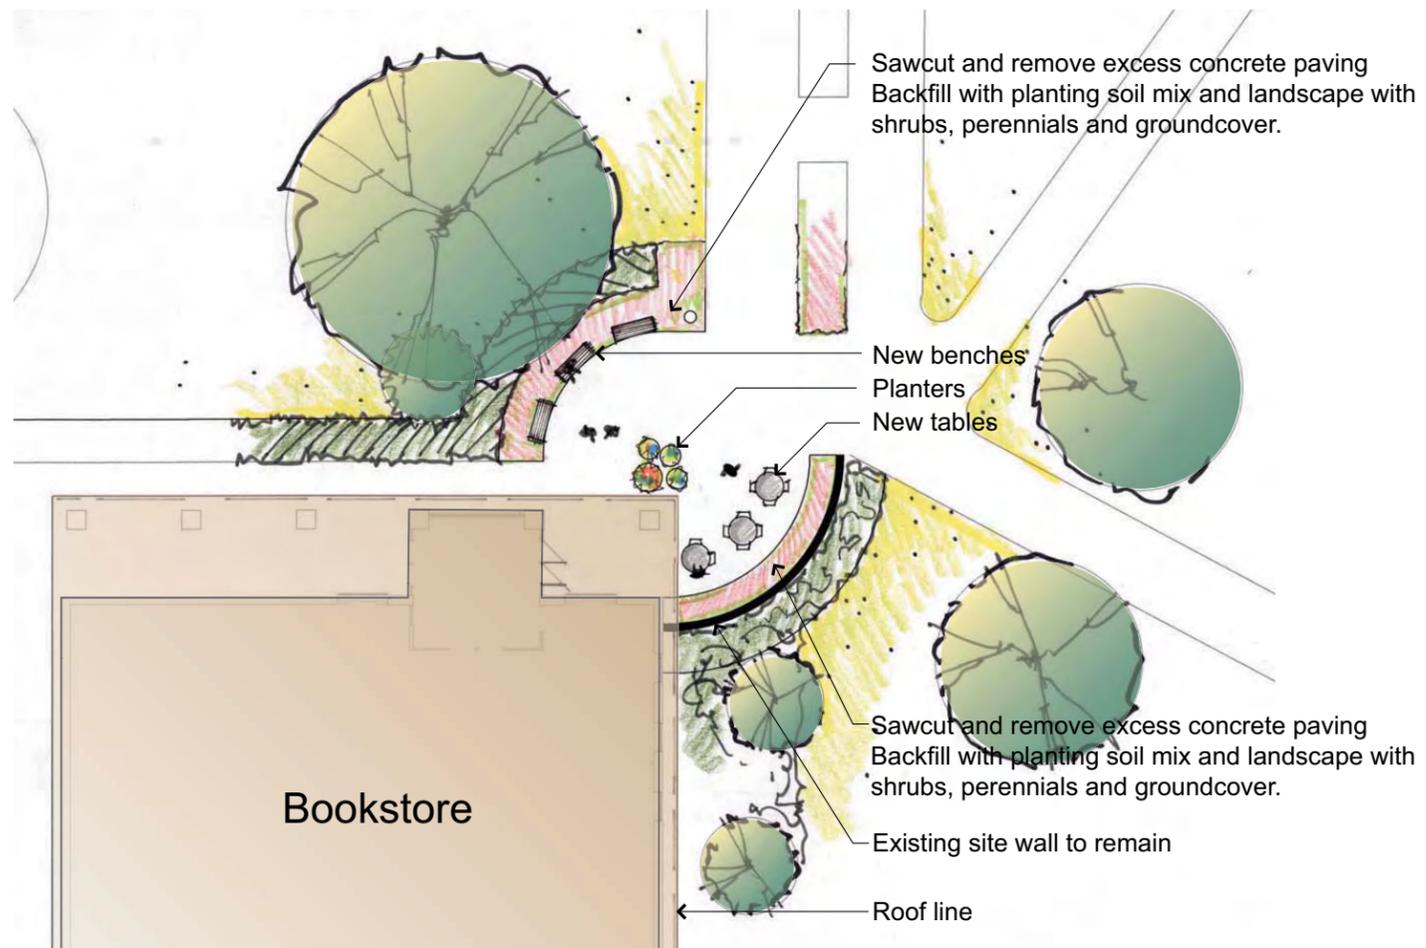
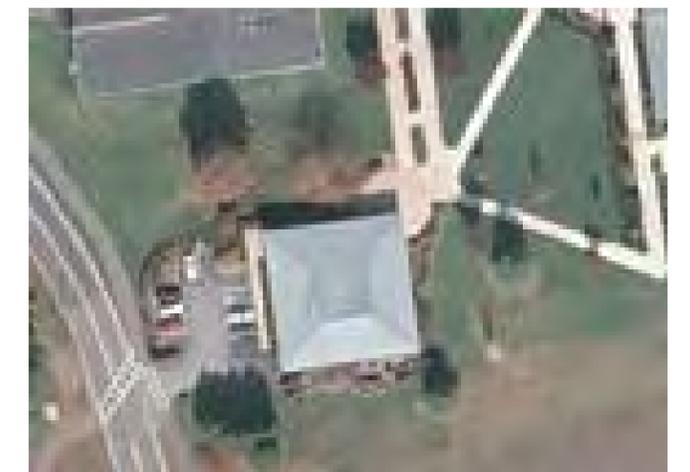
5c

The paved patio in front of the bookstore is excessively large and sparsely furnished.

Propose the removal of excess paving and replacement with ornamental landscape plantings. Replace existing benches, trash receptacles, tables and planters with new campus standard.

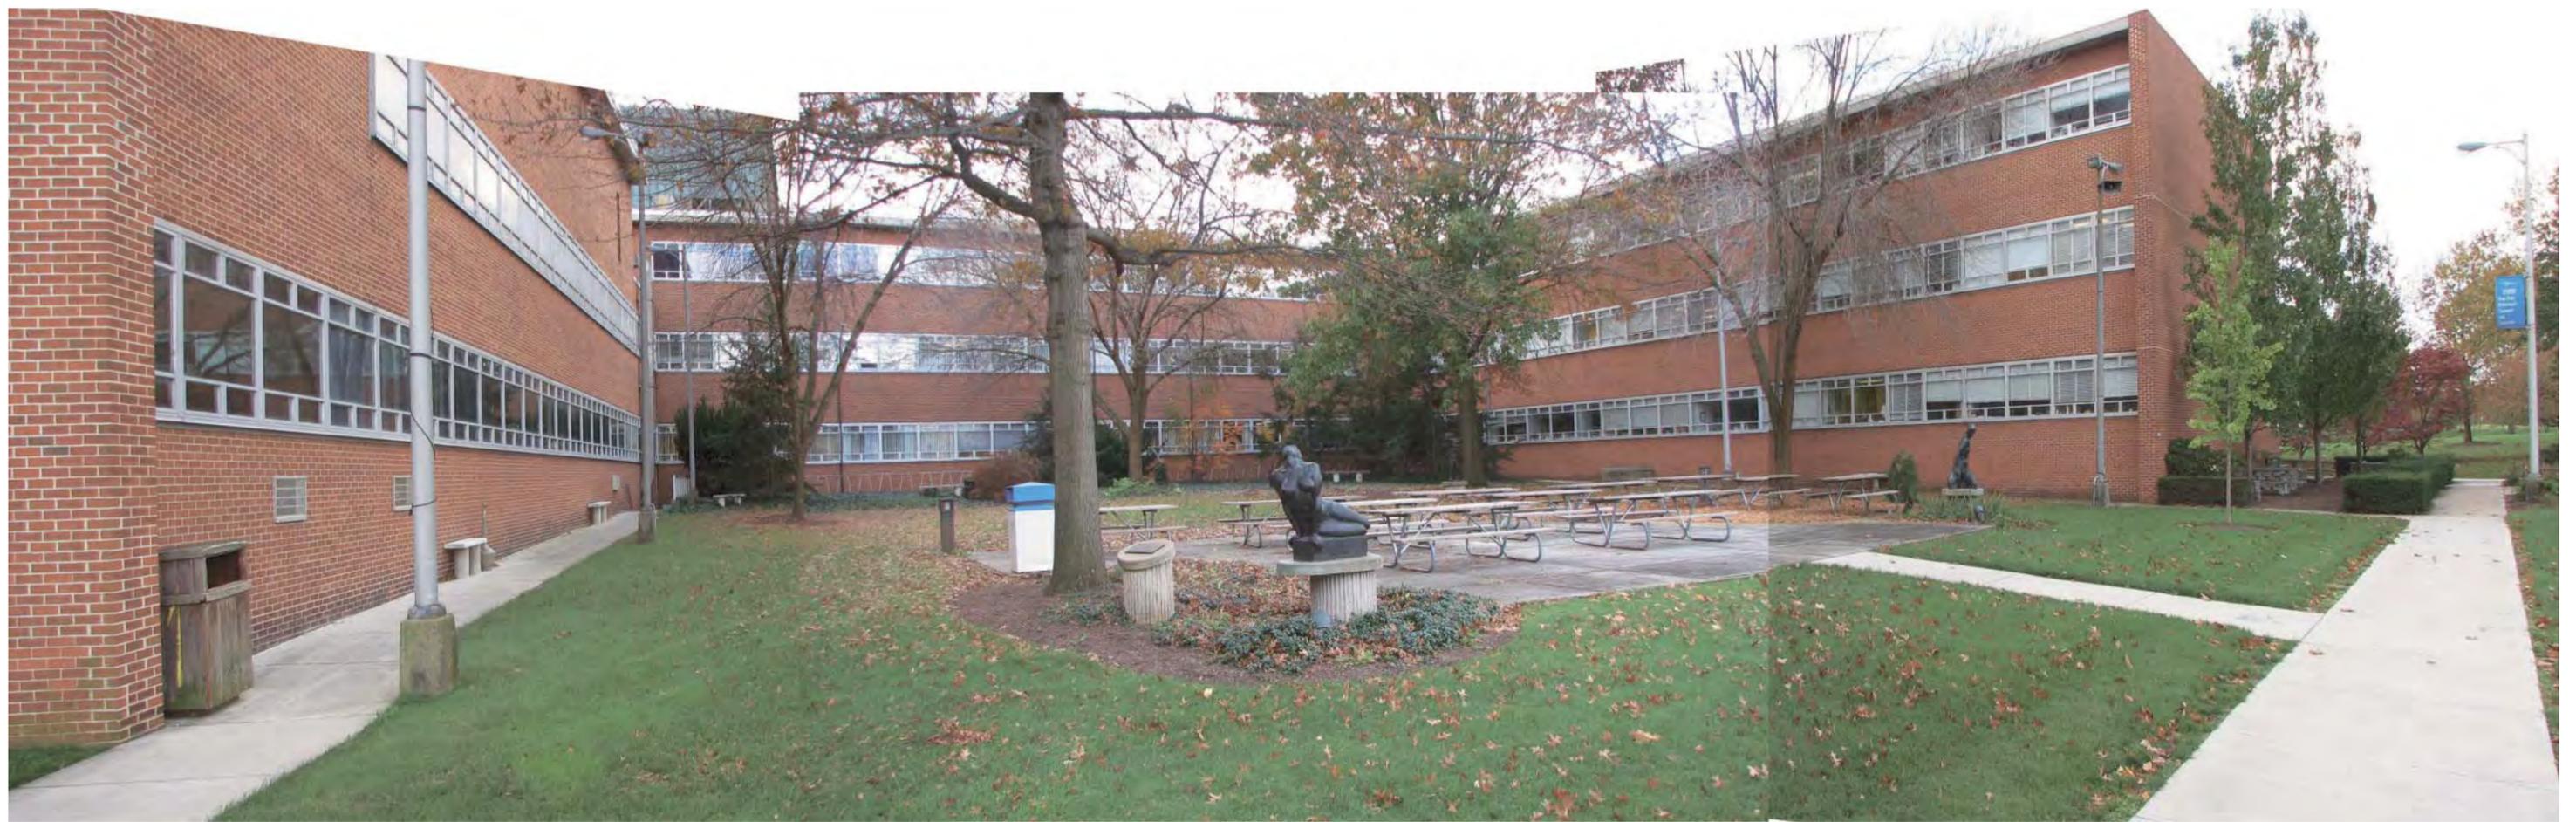
5D

Replace all site furnishings including patio tables, trash receptacles and site lighting. Pressure wash patio surface to remove dirt and stains. Supplement landscape plantings.

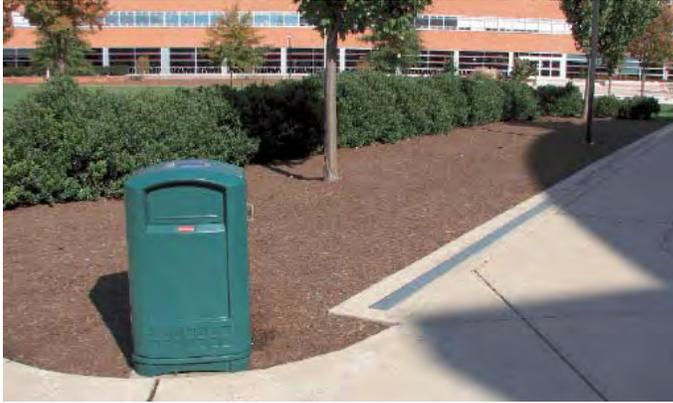
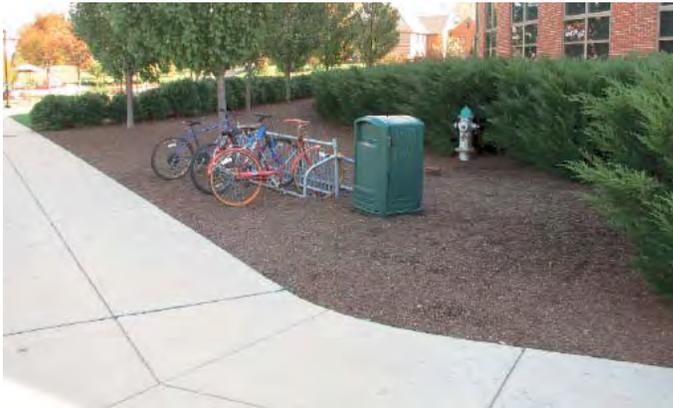
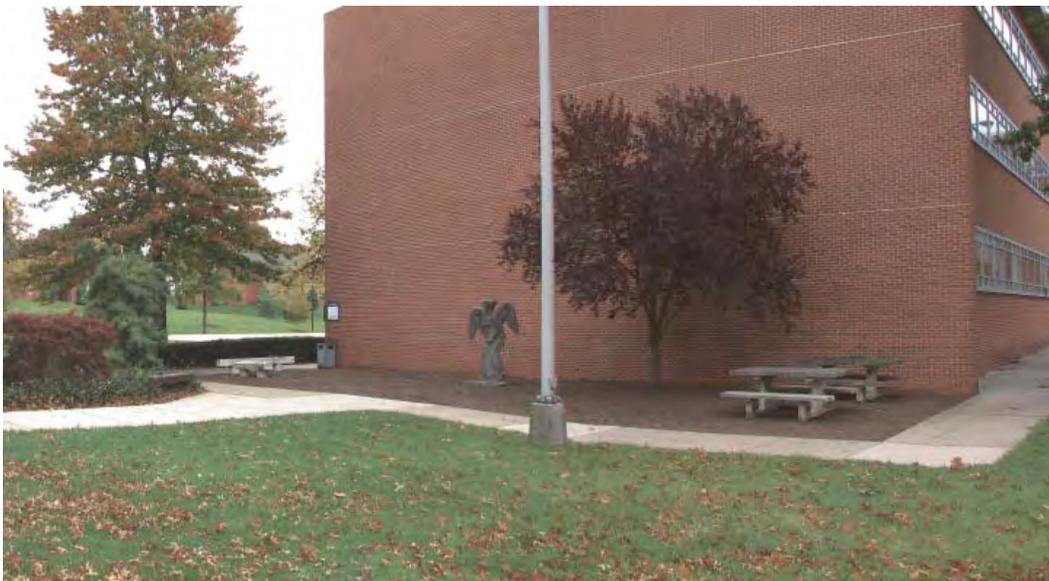
5E Landscape Improvement

The photographic examples at left illustrate landscape planting beds that lack completion. Expansive mulched beds should be supplemented with shrub and groundcover landscape plantings. Site furnishings such as those shown should be appropriately sited on hard surfaces outside of landscape beds.

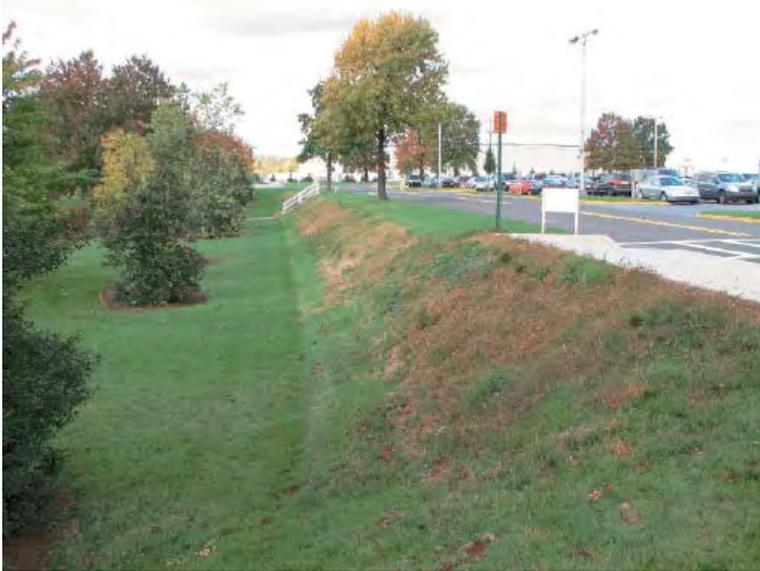
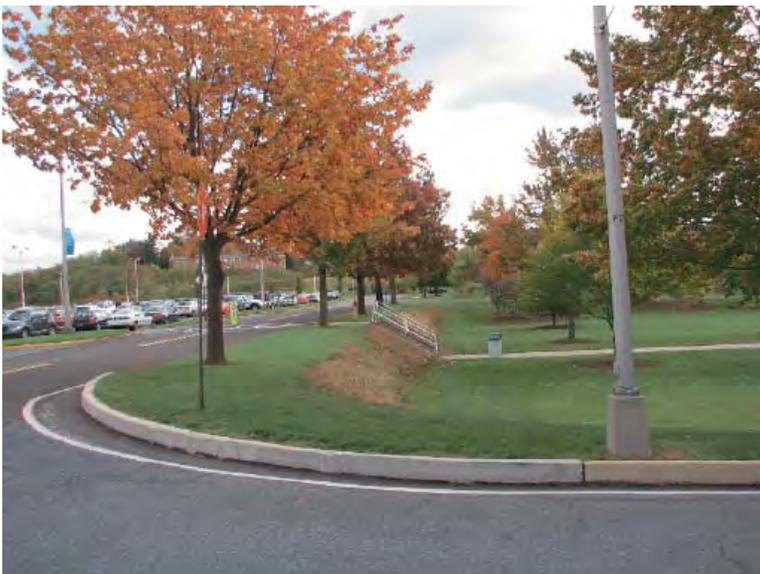
5^F Landscape Improvement

The degree of slope on existing bank makes maintenance of these areas difficult and hazardous. Recommend the replacement of grass with mulched planting beds.

In lieu of planting beds, the gradient in these sloped areas could be lessened and lawn areas restored by placement of waste clean fill material from other earthwork projects on campus.

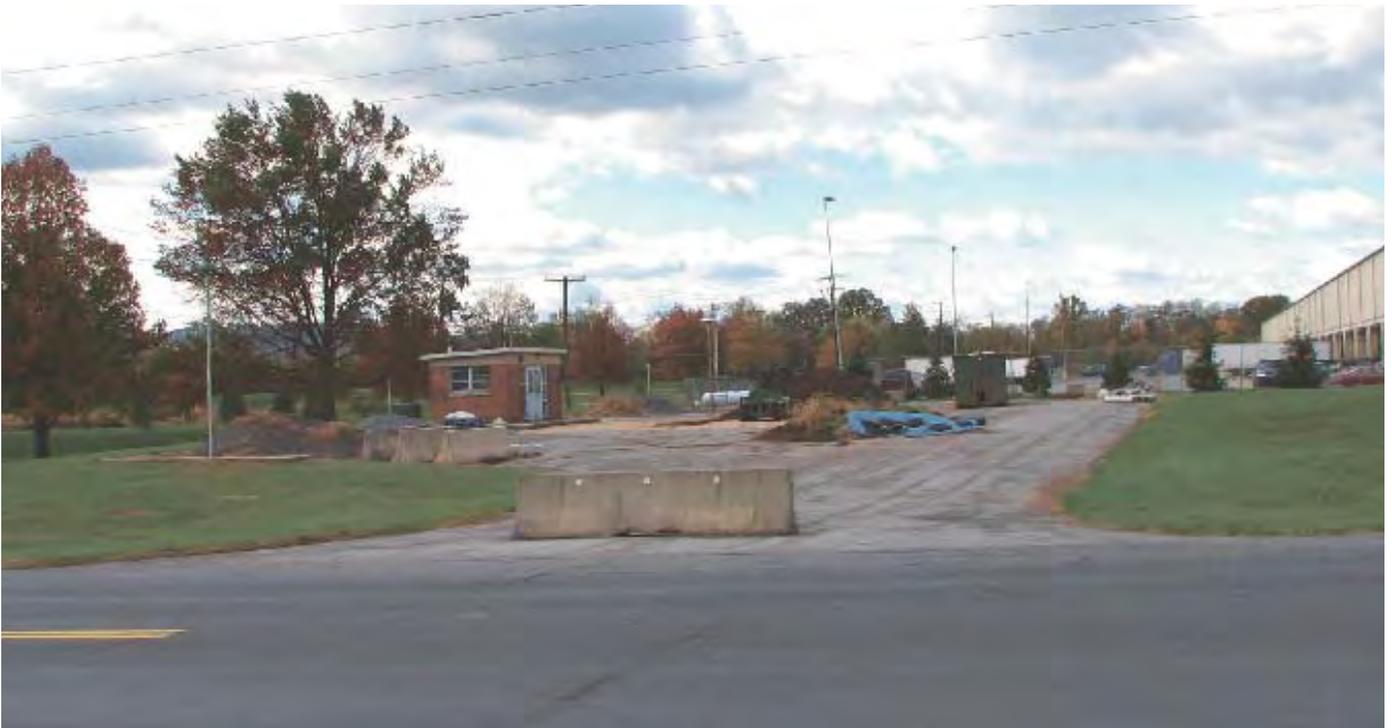
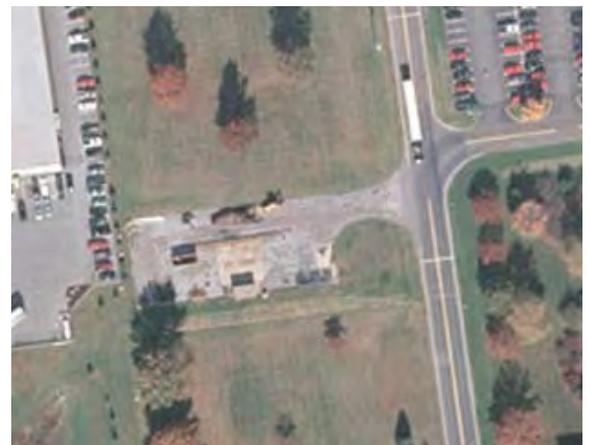
5G Landscape Improvement Improvement Recommendation

Material stockpiles and maintenance equipment should be relocated from this area. Remove paved surface and replace with lawn.

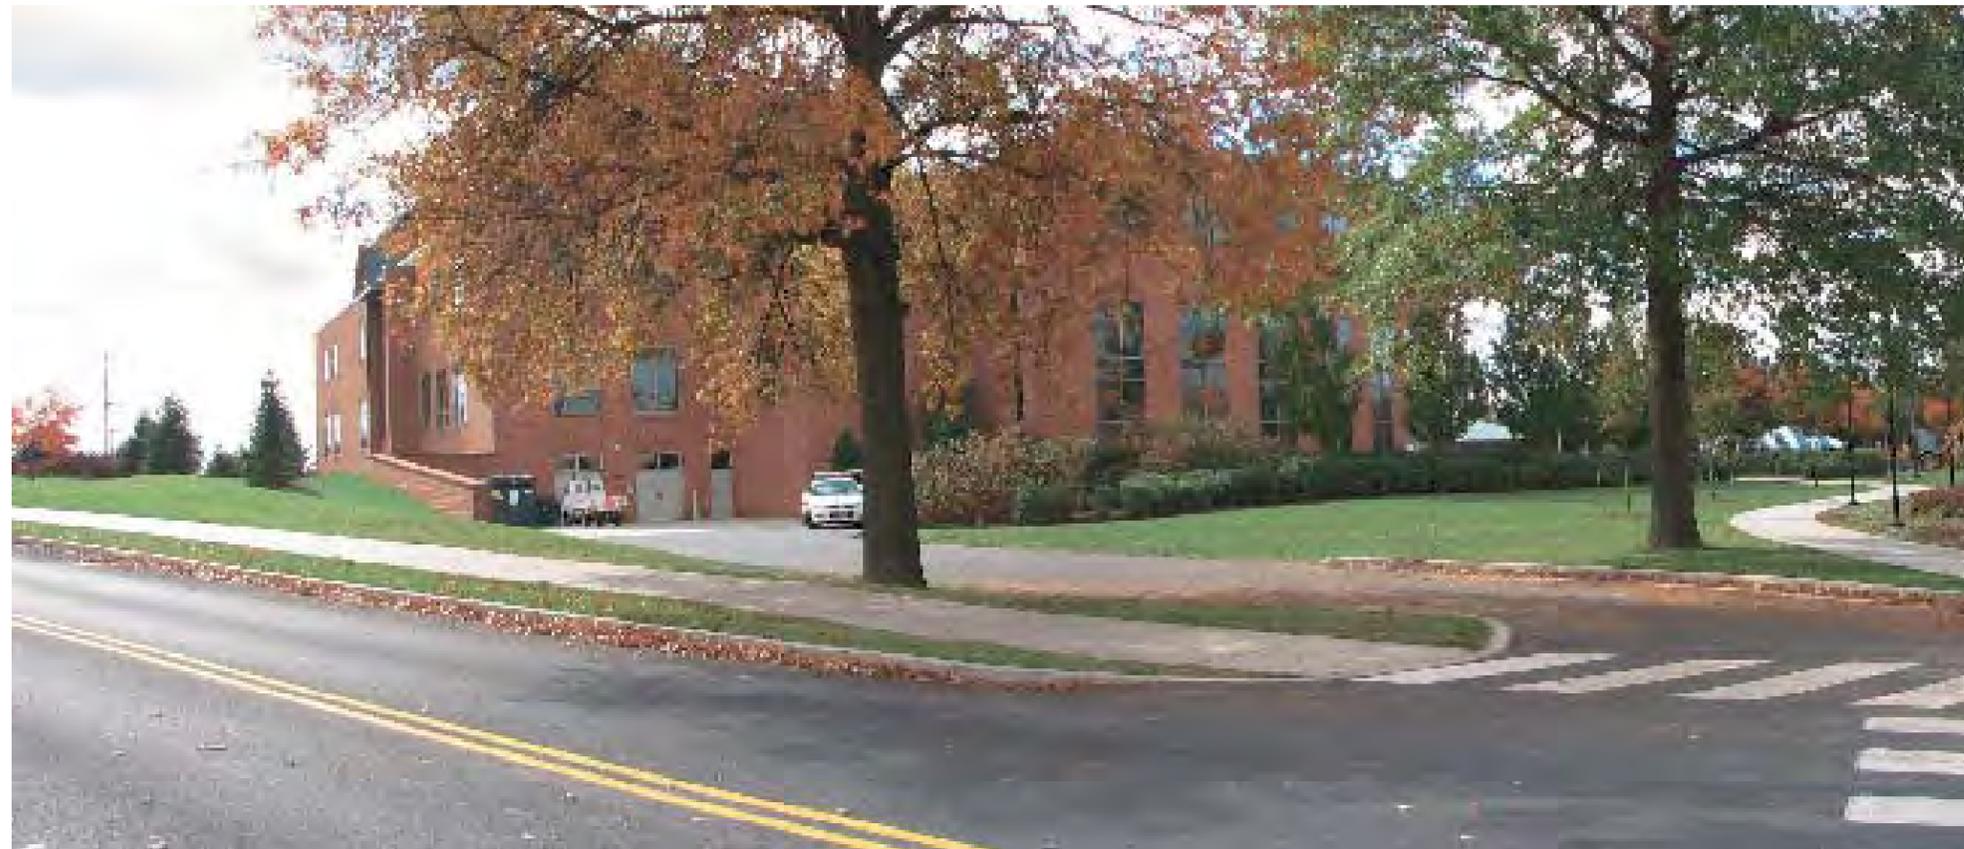
5J

Provide supplemental screening of service area on the north side of the Library. Screening can be comprised of landscape plantings and/or fence and gate structure.

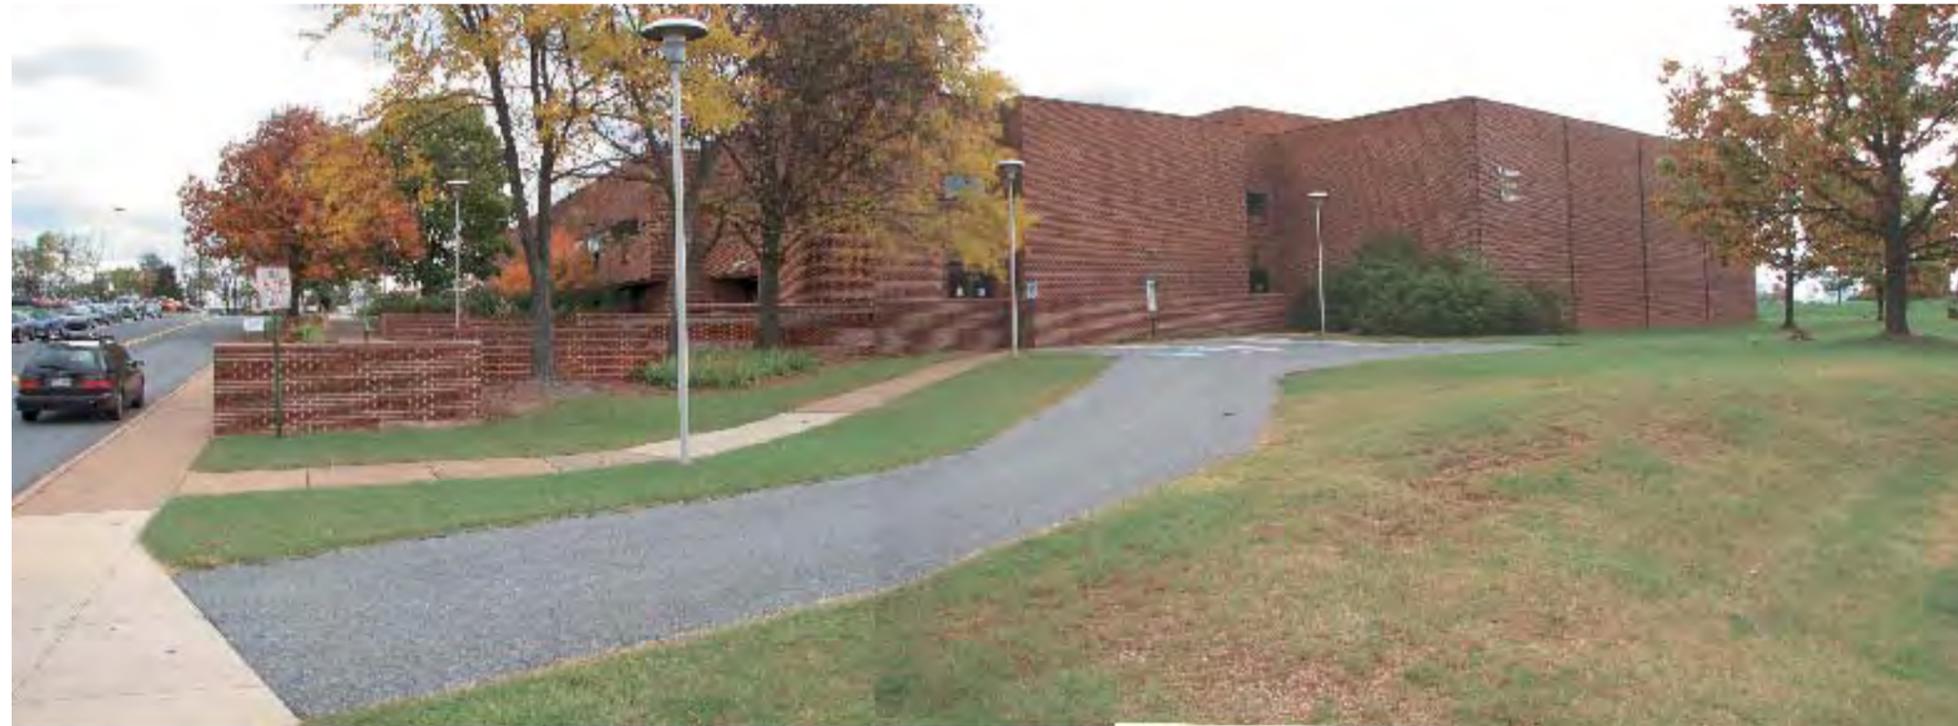
Landscape Improvement **5K**

The first view of a building upon entering campus from Rt 230 is focused on the southwest corner of the CUB. Additional landscape plantings strategically located at this corner would enhance the architecture and screen the parking.

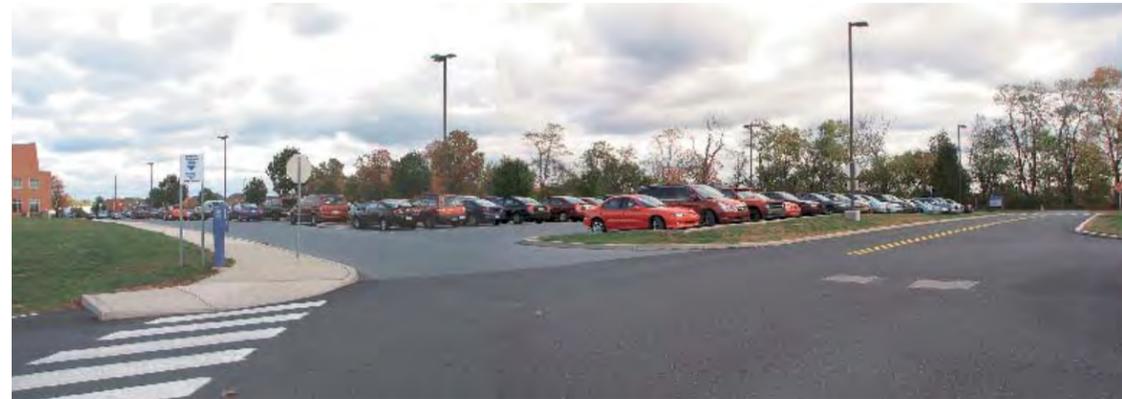
Landscape Improvement ^{5L}

A landscape buffer including trees, shrubs and groundcover should be planted around the perimeter of the existing parking lot. Islands within the lot should be landscaped as well.

The walkway between the Library and the CUB is heavily traveled. Landscaping and site furnishings along this important pedestrian circulation route is recommended.
