Penn State
Harrisburg
The Capital College

Campus Exterior Architectural Plan
November 2006

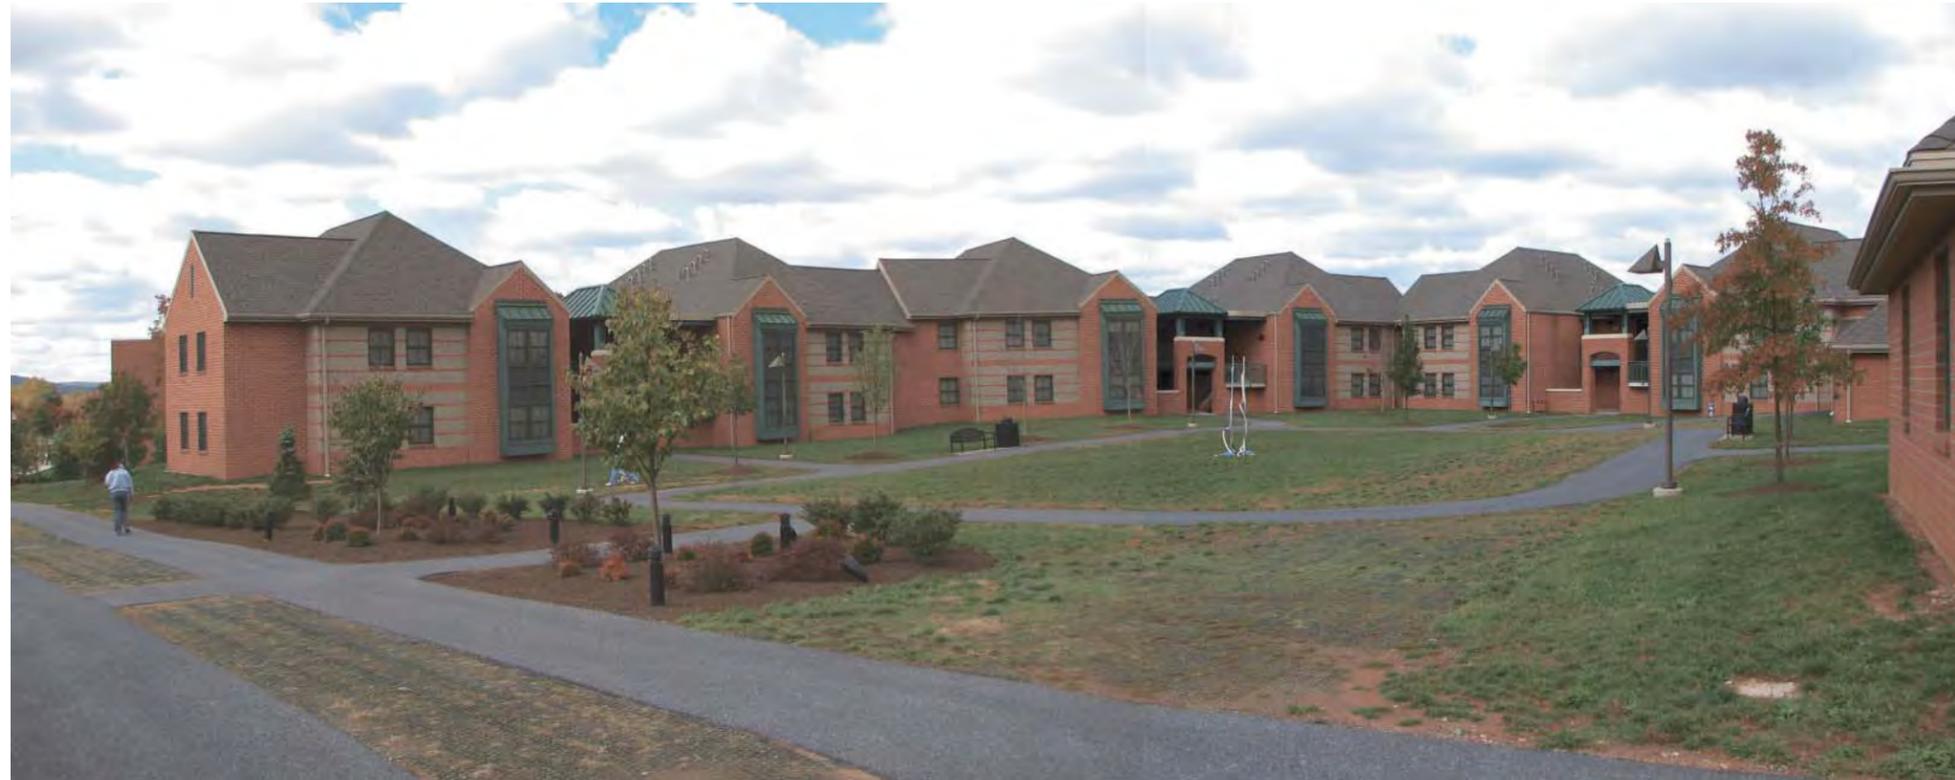
Housing Quad

Landscape plantings in and around the student housing village is sparse. Various mechanical equipment is not appropriately screened from view. Turf areas within quads are worn.

A landscaping plan addressing aesthetic and maintenance concerns should be developed and implemented. Annual lawn aeration, fertilizing and weed control programs should be initiated.

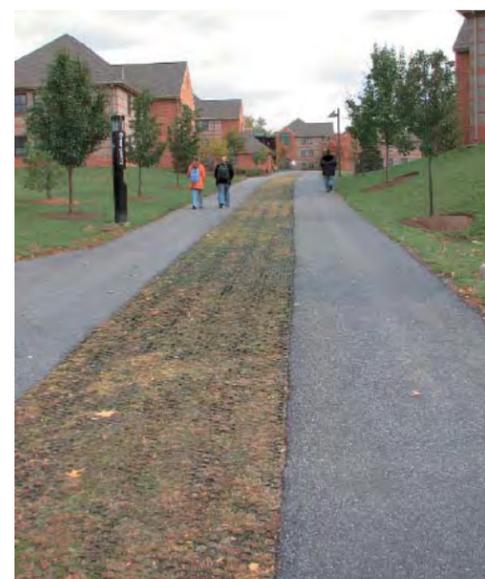
"Grass Pave"

Existing "grass pave" surfacing is not functioning properly. Installation procedures must be rigidly adhered to for such a system to be successful. Recommend removal and replacement to achieve desired turf cover and strength to carry vehicular traffic.

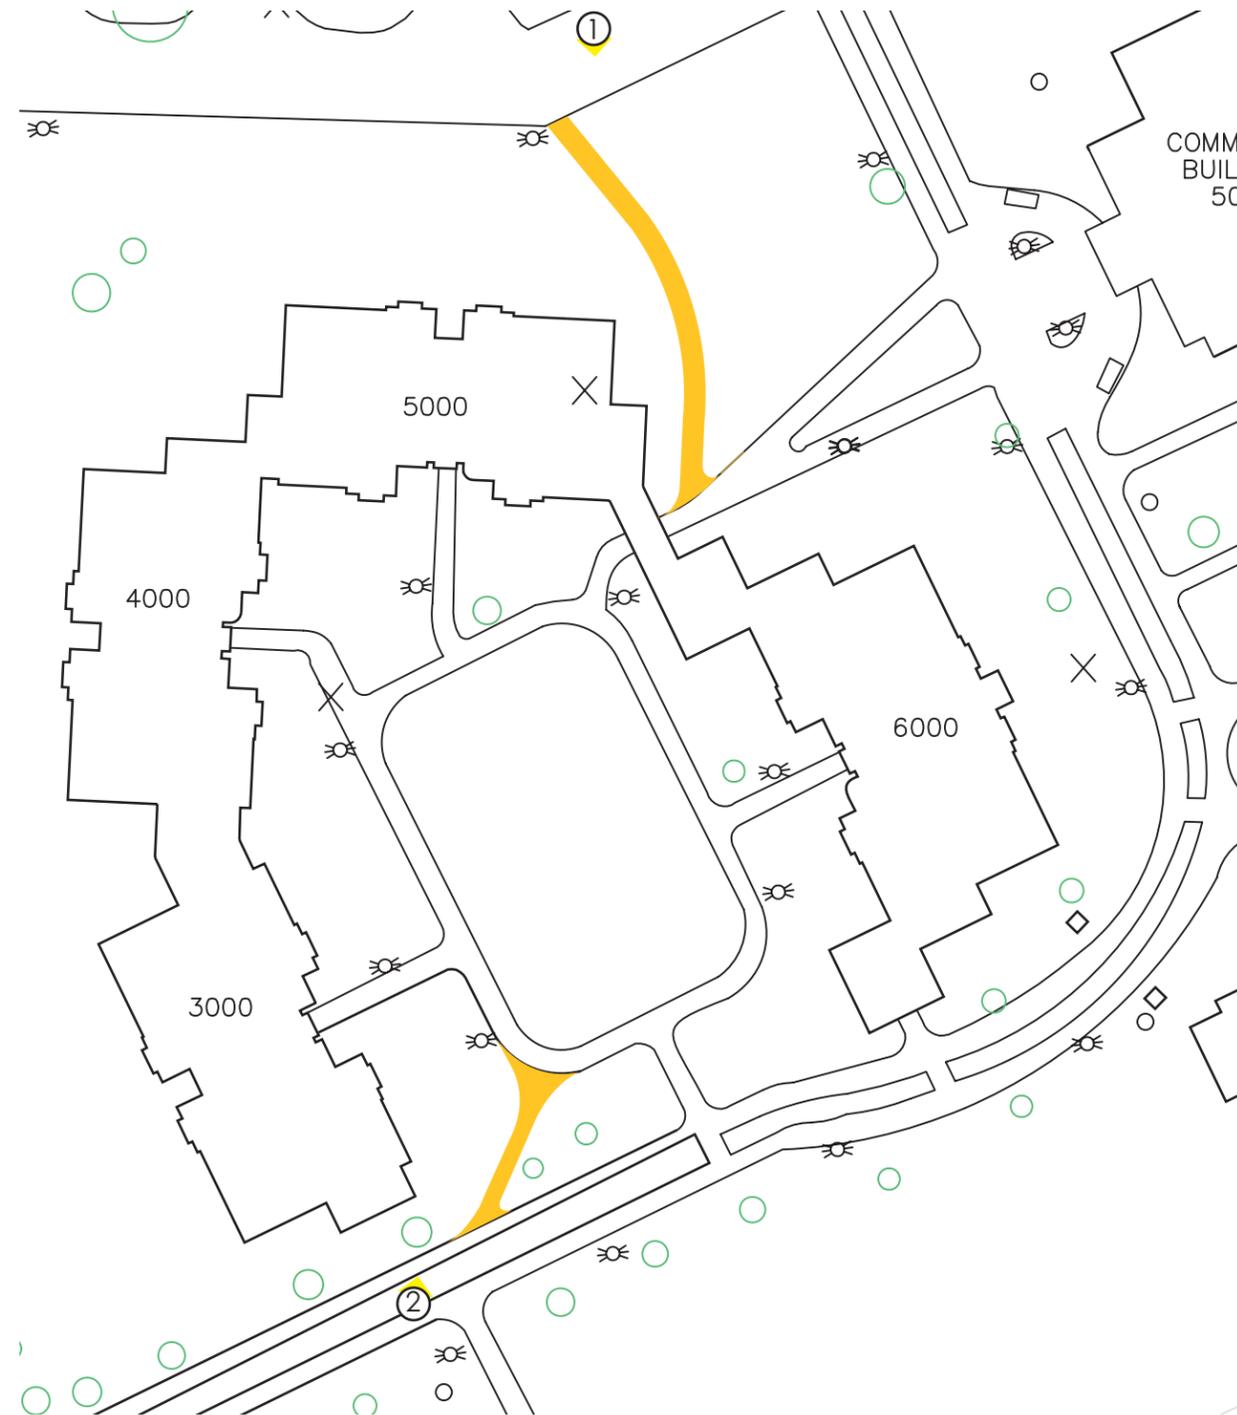
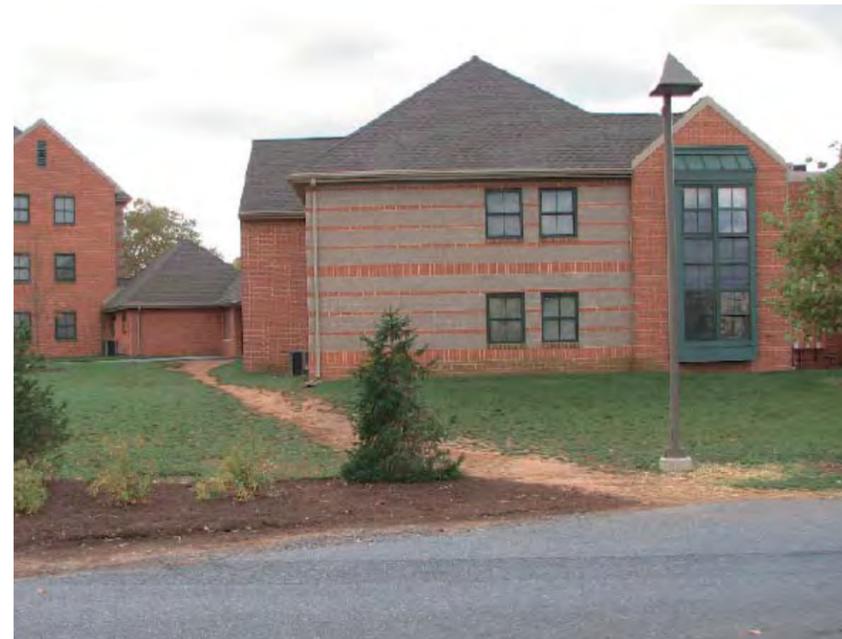
Walkway Installations ⁶

Off-walkway pedestrian circulation within the housing village has developed. These paths reflect the desired route of pedestrian flow. The pathways should be surfaced and maintained.
