Penn State DU1001S

Campus Exterior Architectural Plan
October 2009

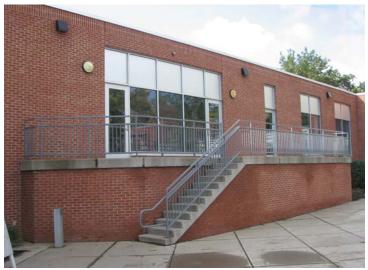
DEF Patio

The opportunity for day to day informal use of the terrace outside of the DEF Building is missed because it is unfurnished.

Recommend the placement of movable cafe tables and chairs that can serve the breakout function from the conference room as well as the potential daily informal user.

The inclusion of planters on the patio will enhance the comfort of the space as well.

Consider sidewalk adjustments to accommodate foundation planting at base of patio or place planters to soften the hard edges of wall and walk.

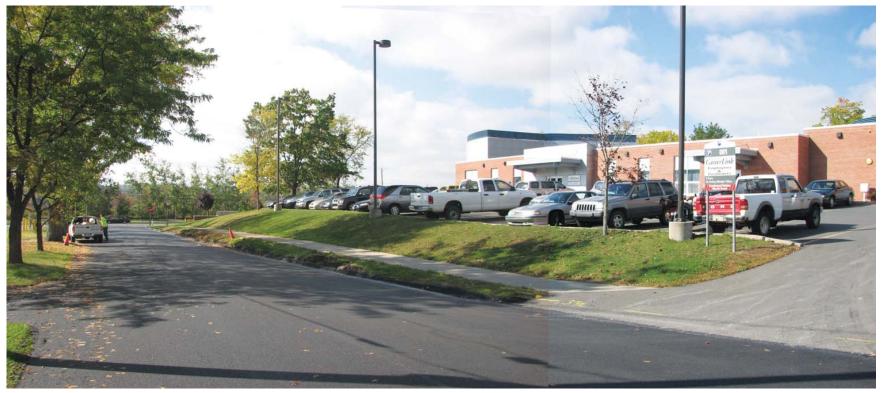
Parking Screen Improvement Recommendation The first impression of the carr proach is or

approach is one of parked cars.

Recommend that the slope between the lot and the sidewalk be planted with trees and shrubs to screen and soften this first impression.

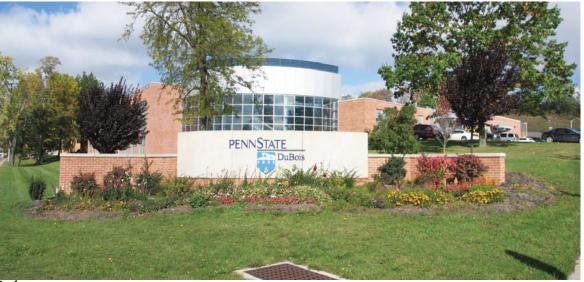
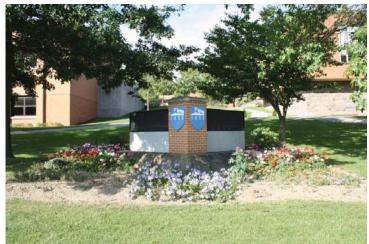
Landscape treatment at campus entrance signs is

too dependent on perennial/annual flower displays.

consisting of shrubs and groundcovers with multiple

Recommend a simplified planting scheme

season interest.

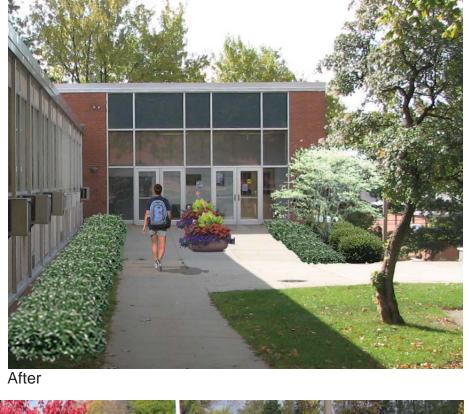
Swift Building Entrance

This entrance to Swift Building fronts on one of the most prominent open spaces in the campus core. The area immediately outside the doors is characterized by excessive pavement. The handrail along the west edge is in disrepair.

Existing rail in disrepair. Widening and planting a barrier will allow for removal.

Recommend that the paved area be reduced and supplemented with permanent landscape plantings at the entrance. By reducing the width of the paving and installing the vegetated barrier the railing can be eliminated.

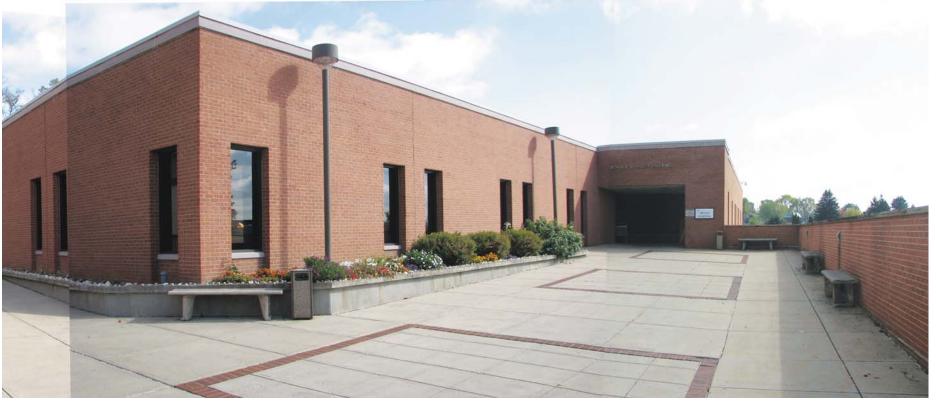
Smeal Building Wall

The cast concrete walls at both ends of Smeal Building are unsightly and unfinished looking. This side of the building is Penn State's face to the public.

Recommend that the walls be veneered with stone to match the base of Swift Building.

Supplemental landscape plantings can soften and enhance the stark aesthetic of this prominent visual opening to Rt. 255.

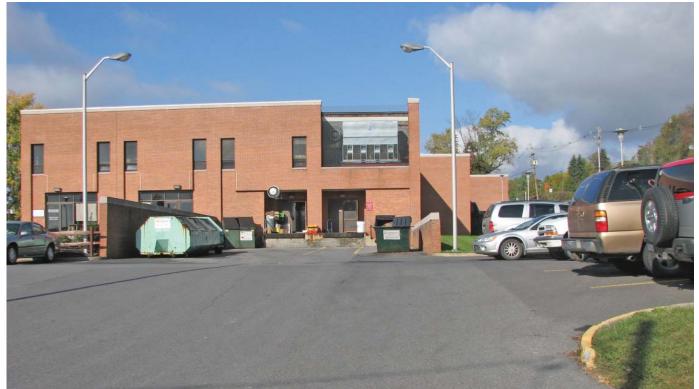
Refuse dumpsters and service dock of Hiller
Building could be effectively screened by installing
a gate system similar to other screening at the
campus.

Additional landscape plantings would supplement the screening of the area.

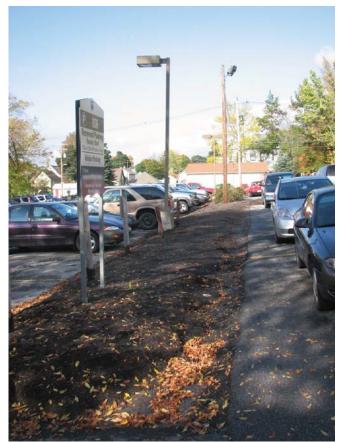
Existing mulch bed in parking lot.

The existing parking lot west of the Multi-Purpose Building is inefficient and inadequately screened.

This recommendation calls for the realignment of parking stalls, aisles and lot entrances. New parking lot lighting should be installed.
