Worthington Scranton

Campus Exterior Architectural Plan

Existing Conditions Inventory

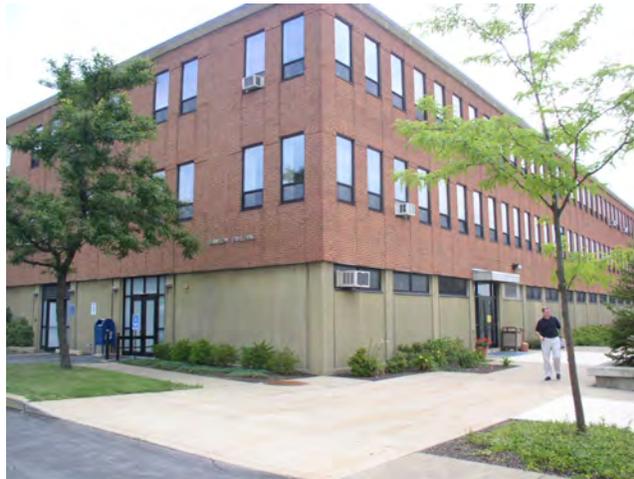
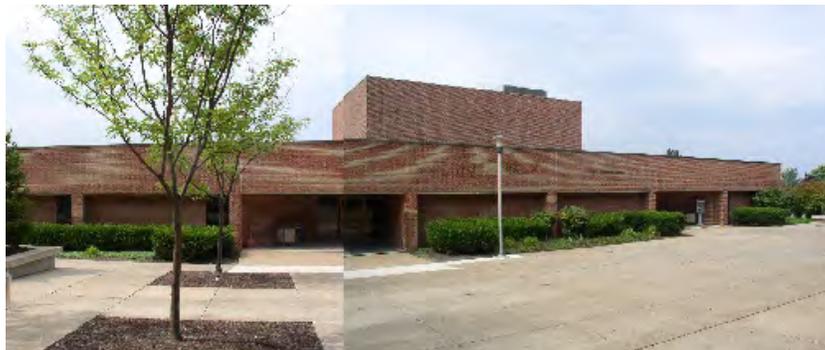
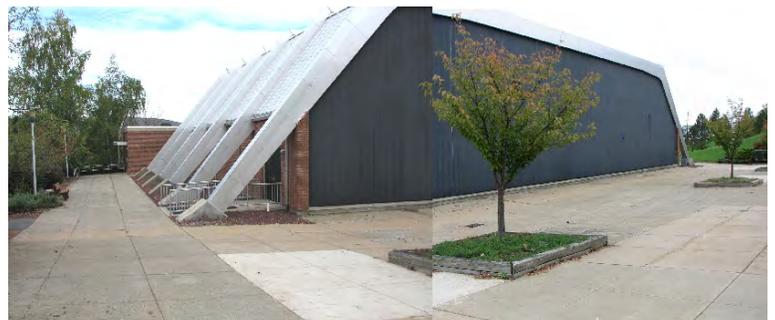
Architecture

Major architectural modifications, additions, and new construction are beyond the scope of this CEAP. With the exception of a few structures, the predominant building material is brick and the architectural style contemporary. These factors should be considered when developing exterior improvements such as walls, site furnishings, lighting and planting designs.

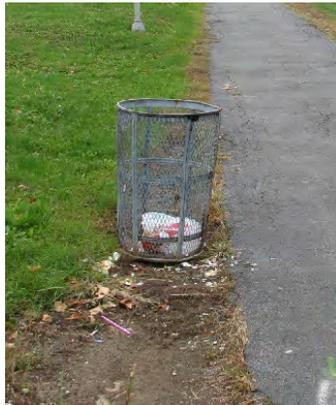
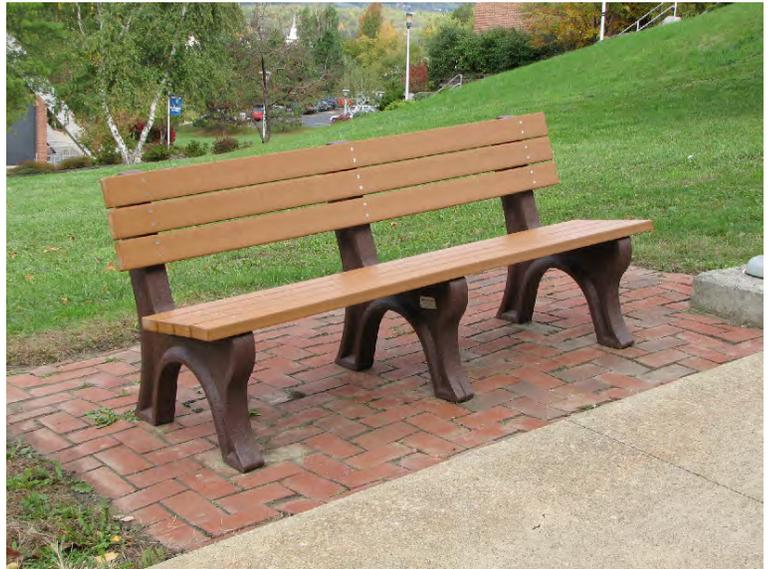
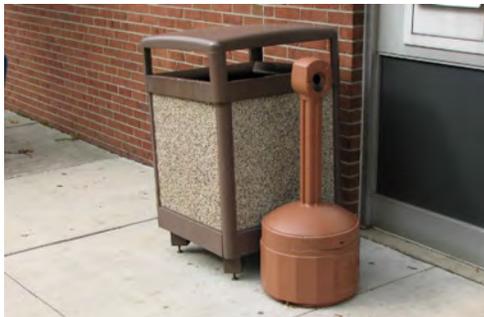
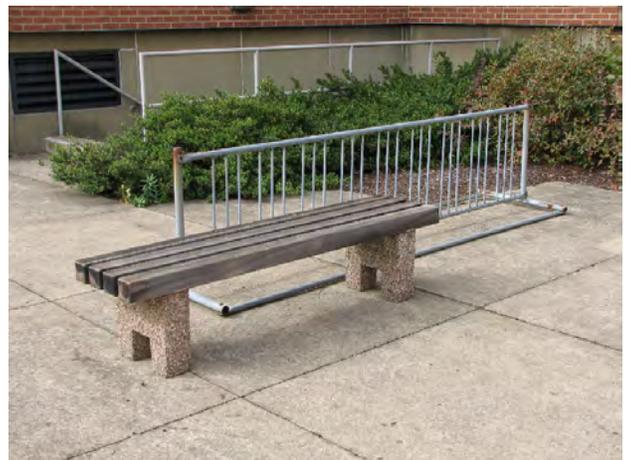
Site Furnishings

A variety of types and styles of benches, tables, trash receptacles and planters are spread across the campus. The opportunity exists to establish a uniform aesthetic character, campus wide, through the use of stylistically complimentary furnishings.

In addition to aesthetic appropriateness, the longevity and maintenance of site furnishings should be considered when specifying.

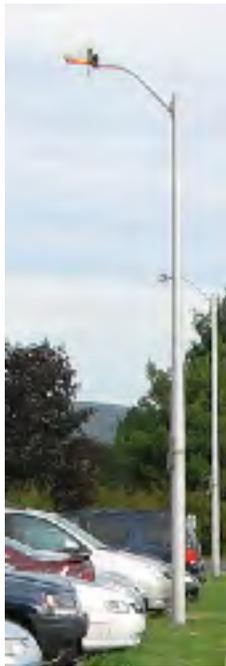
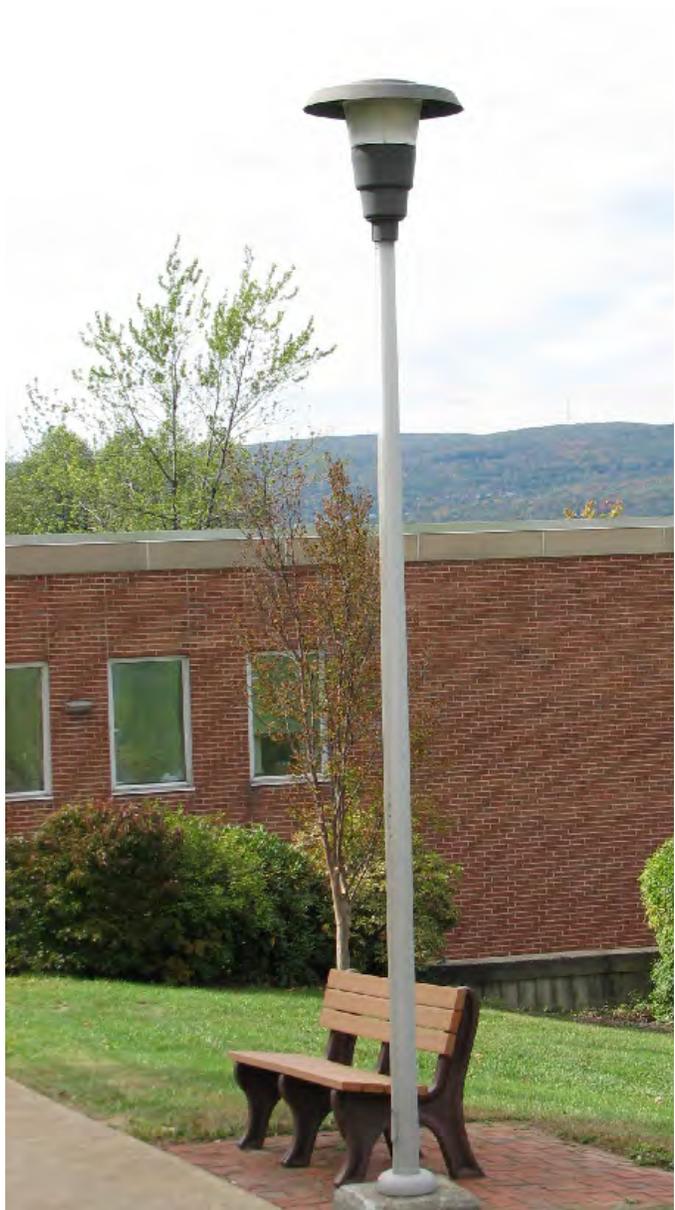
Lighting

Exterior lighting across the campus varies with respect to style and lamp type. A unifying aesthetic effect can be achieved by implementing a comprehensive and stylistically complimentary scheme.

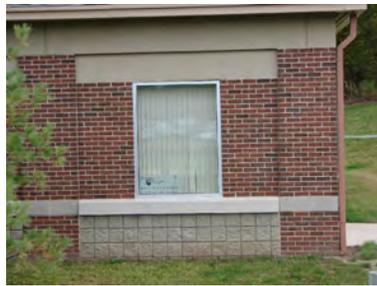
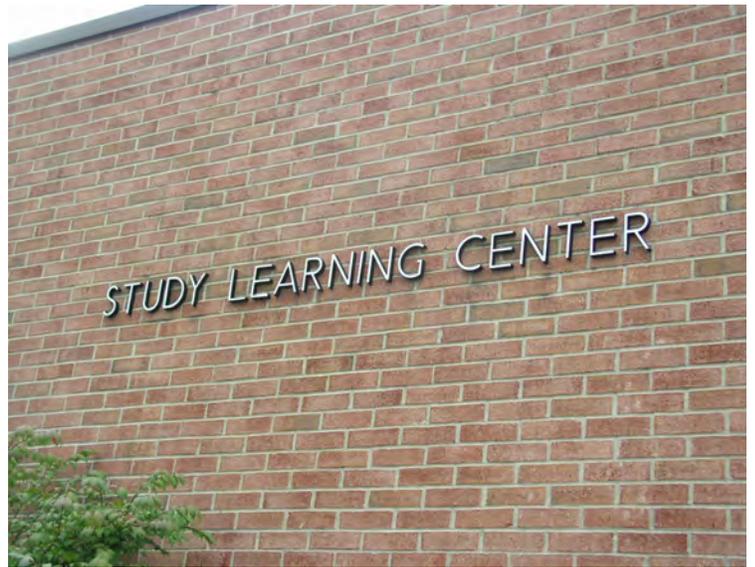
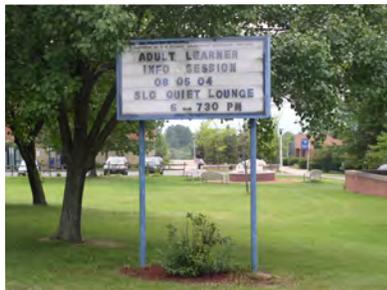
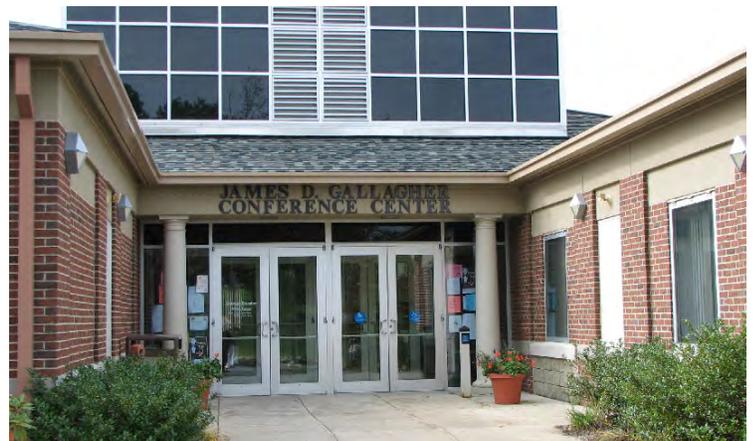
Signage

Campus identification and wayfinding signage is inconsistent stylistically with respect to copy, color, size and detailing.

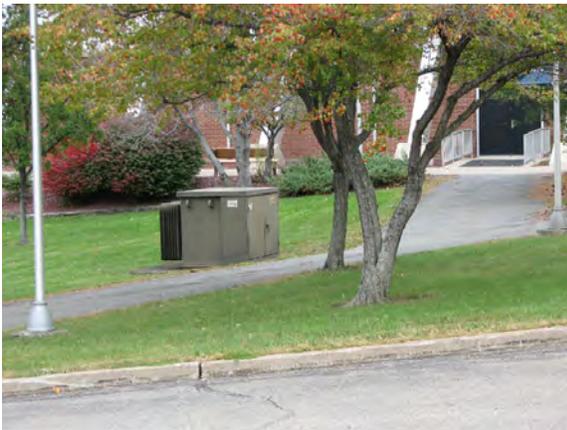
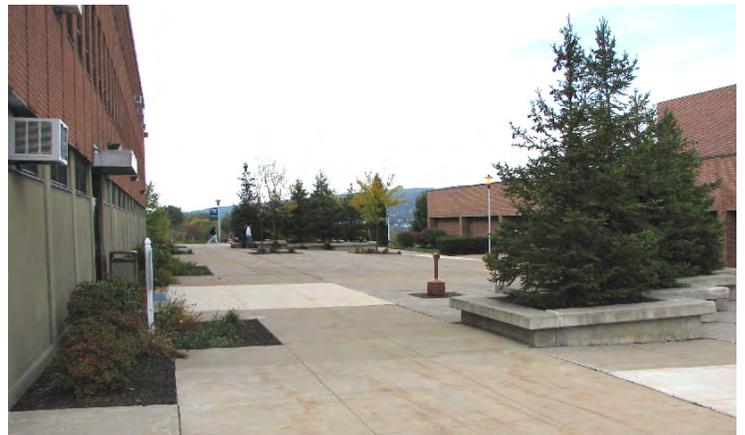
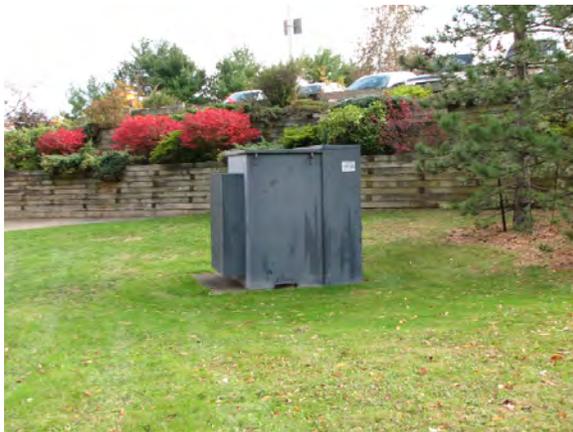
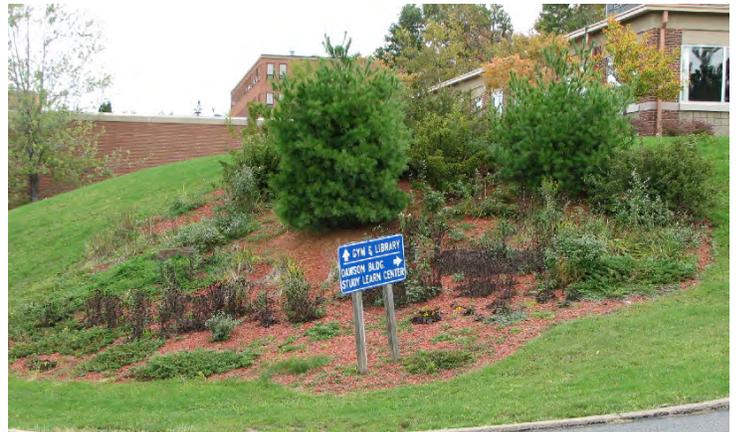
Landscaping

Weed control, slope plantings and shrub maintenance have been noted as areas for improvement. Parking lot and mechanical equipment screening are absent in some cases. The softening effect of additional landscape plantings is absent in some locations. Large non-programmed lawn areas exist across the campus that require significant resources to maintain.

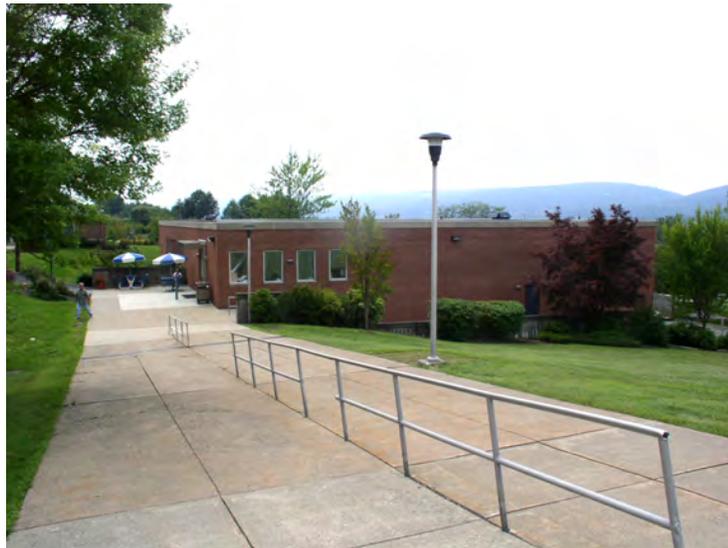
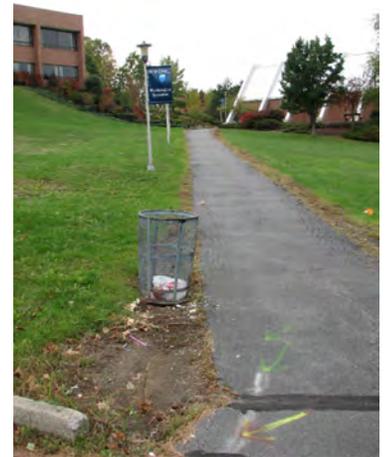
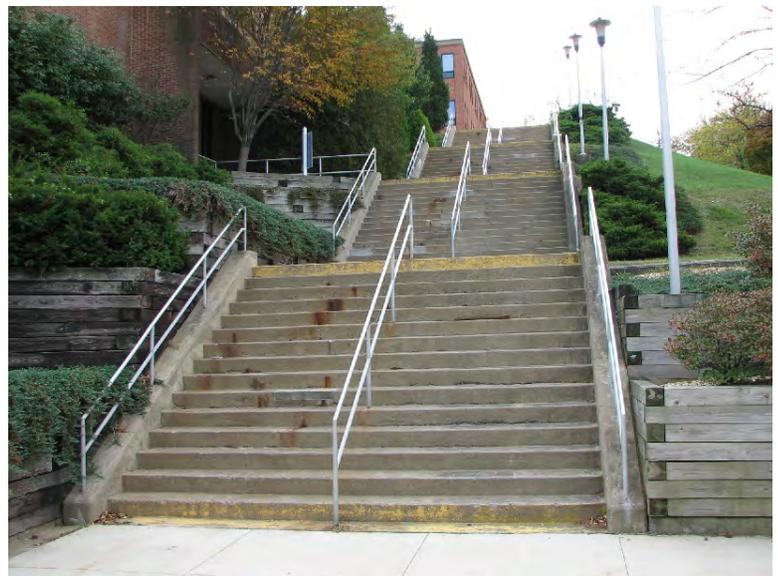
Pedestrian Circulation

ADA compliant pedestrian circulation is and will always be a challenge on this campus due to the topographic condition. Underutilized expansive paved areas exist.

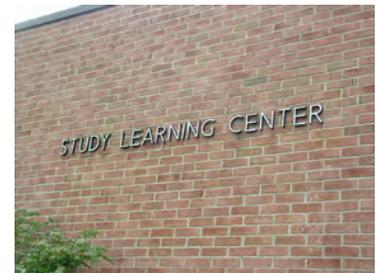
Wall-mounted Building Identifier Sign

- Aluminum cutout letters mounted to non-illuminated painted aluminum backer pan.
- 6" high 1 1/2" deep satin finish letters
- Font style: Gill Sans Light

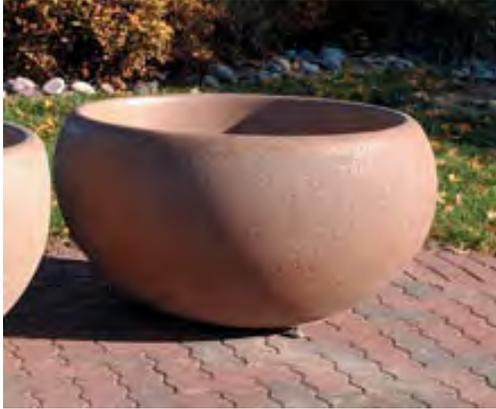
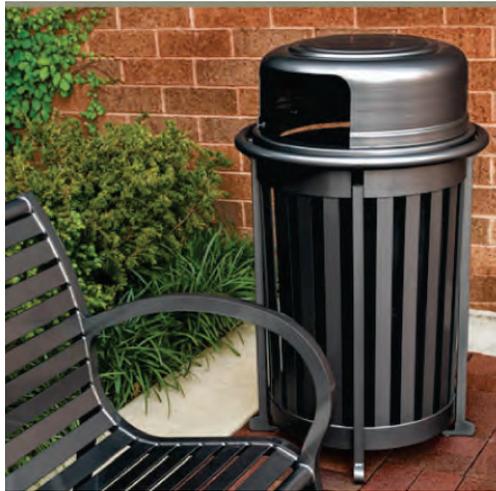
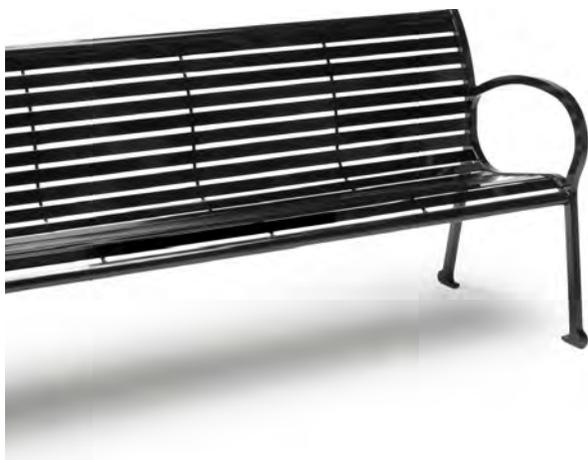
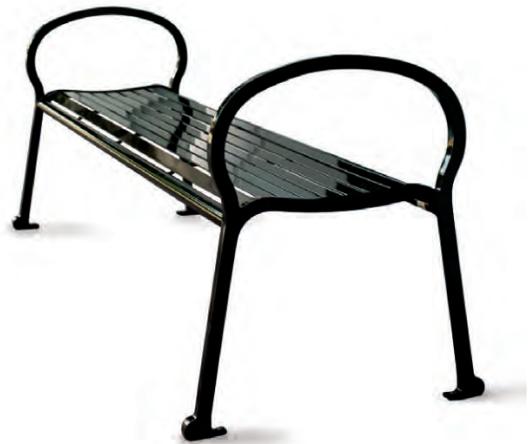
Site Furnishings²

Site furnishings designed in a style “family” provide a unifying aesthetic theme. The example shown here is stylistically neutral making it compatible with varying architectural styles present on the campus. Powder coated metal is attractive, comfortable and durable. Planters should be appropriately sized for the space they occupy and be constructed of durable, quality material

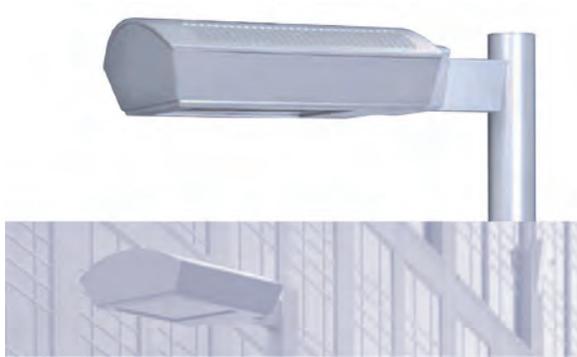
InVue Ascent pole light for roadways, parking and other vehicular oriented areas
Manufacturer: Cooper Lighting

Plan for phased replacement of antiquated, inefficient walkway, roadway and parking lot lighting. The use of metal halide lamps in cut-off luminaires mounted to poles is recommended. Avoid the use of bollards due to vulnerability to snow removal operations and vandalism.

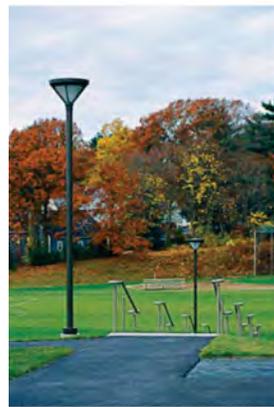
Argent "family" of lights for pedestrian oriented locations.
Manufacturer: Architectural Area Lighting

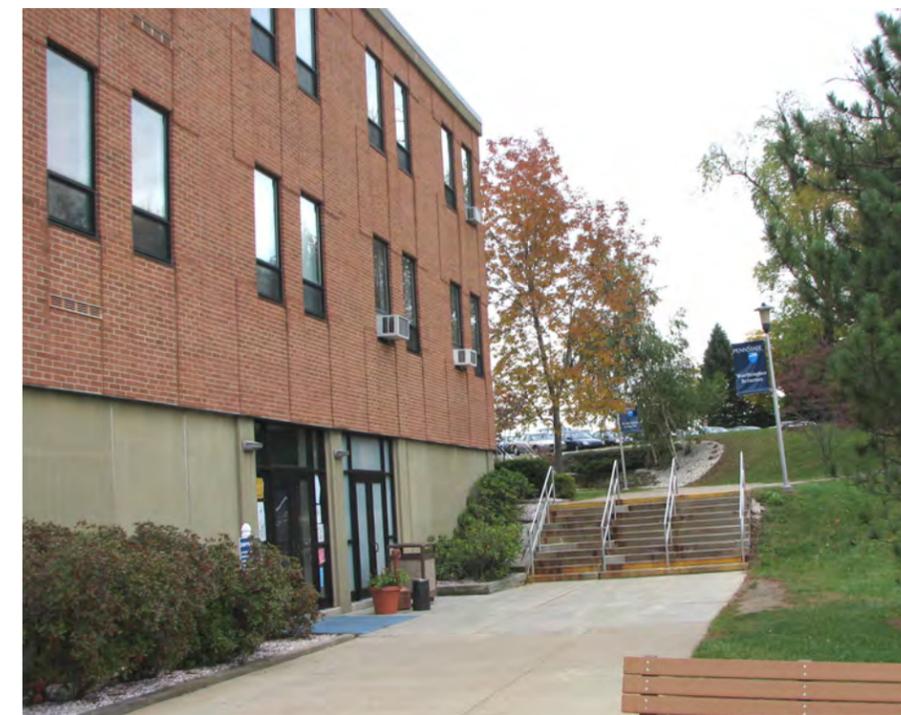
Existing

The existing entry points to Dawson Building are nondescript. A roof or awning structure at each entry point will visually identify the entrance as well as provide shelter from inclement weather. The design and material for the awning must complement the architectural style of the building. Other instances occur across campus that would benefit from this treatment. Examples include the Nursing Education entrance at the Library and Police Services.

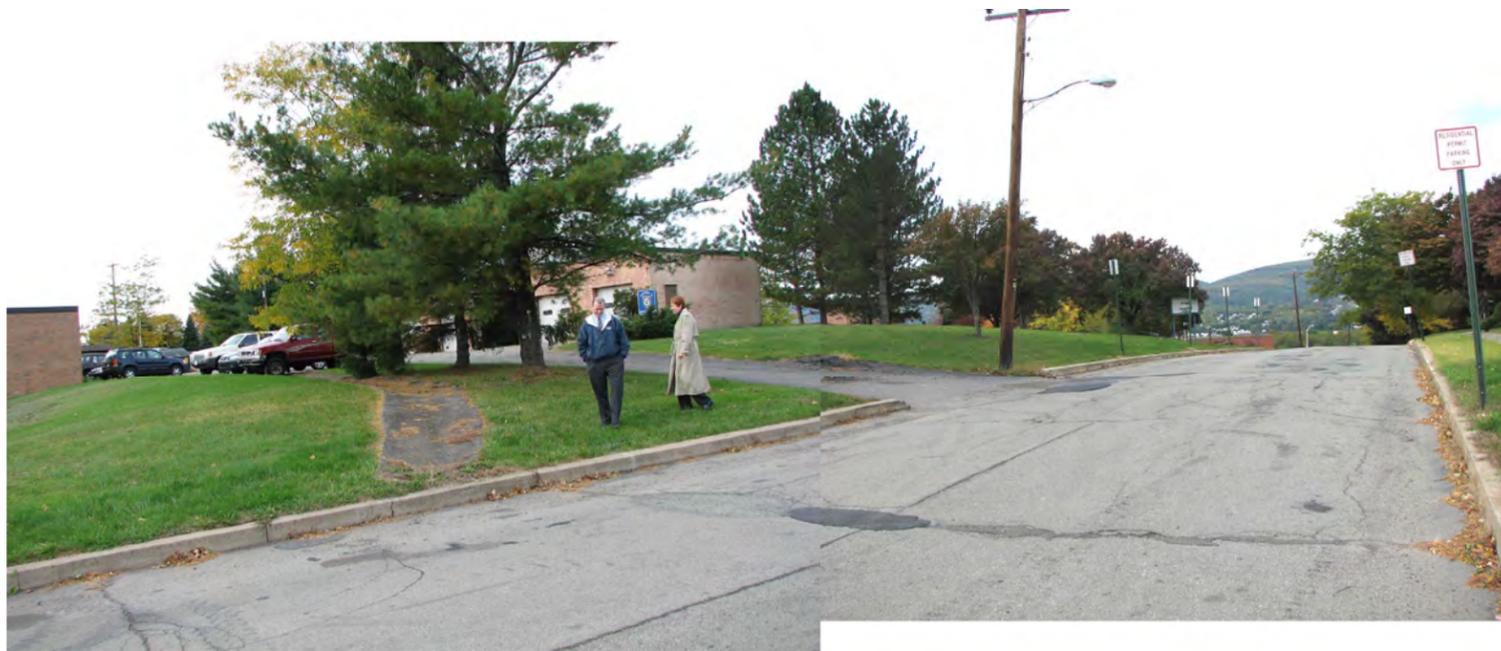
Before

Pedestrian access to campus from public transportation at O'Neill Highway requires walking in the street or grass for at least a portion of the route. Propose the installation of a sidewalk from campus to the highway.

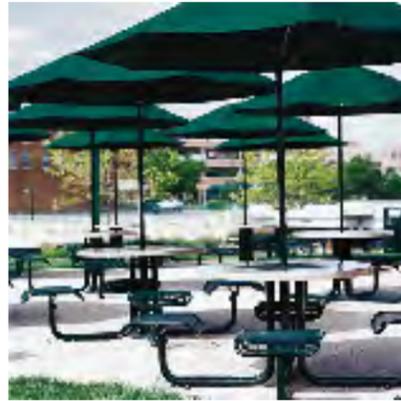
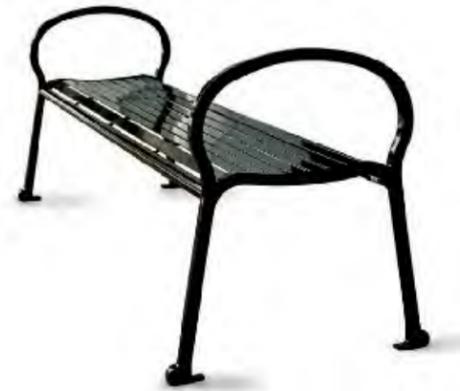
This gathering space south of Dawson Building requires little to enhance its visual quality and thereby its use. Landscape plantings are well established and contain quality materials. Several of the improvement recommendations cited elsewhere in this document can be implemented here as well as those noted.

Replace and supplement eclectic mix of existing site furnishings with new complimentary benches, tables and lighting.

Install displays of annual flowers confined to existing pavement penetrations

Pressure washing will "refresh" the appearance of stained pavement.

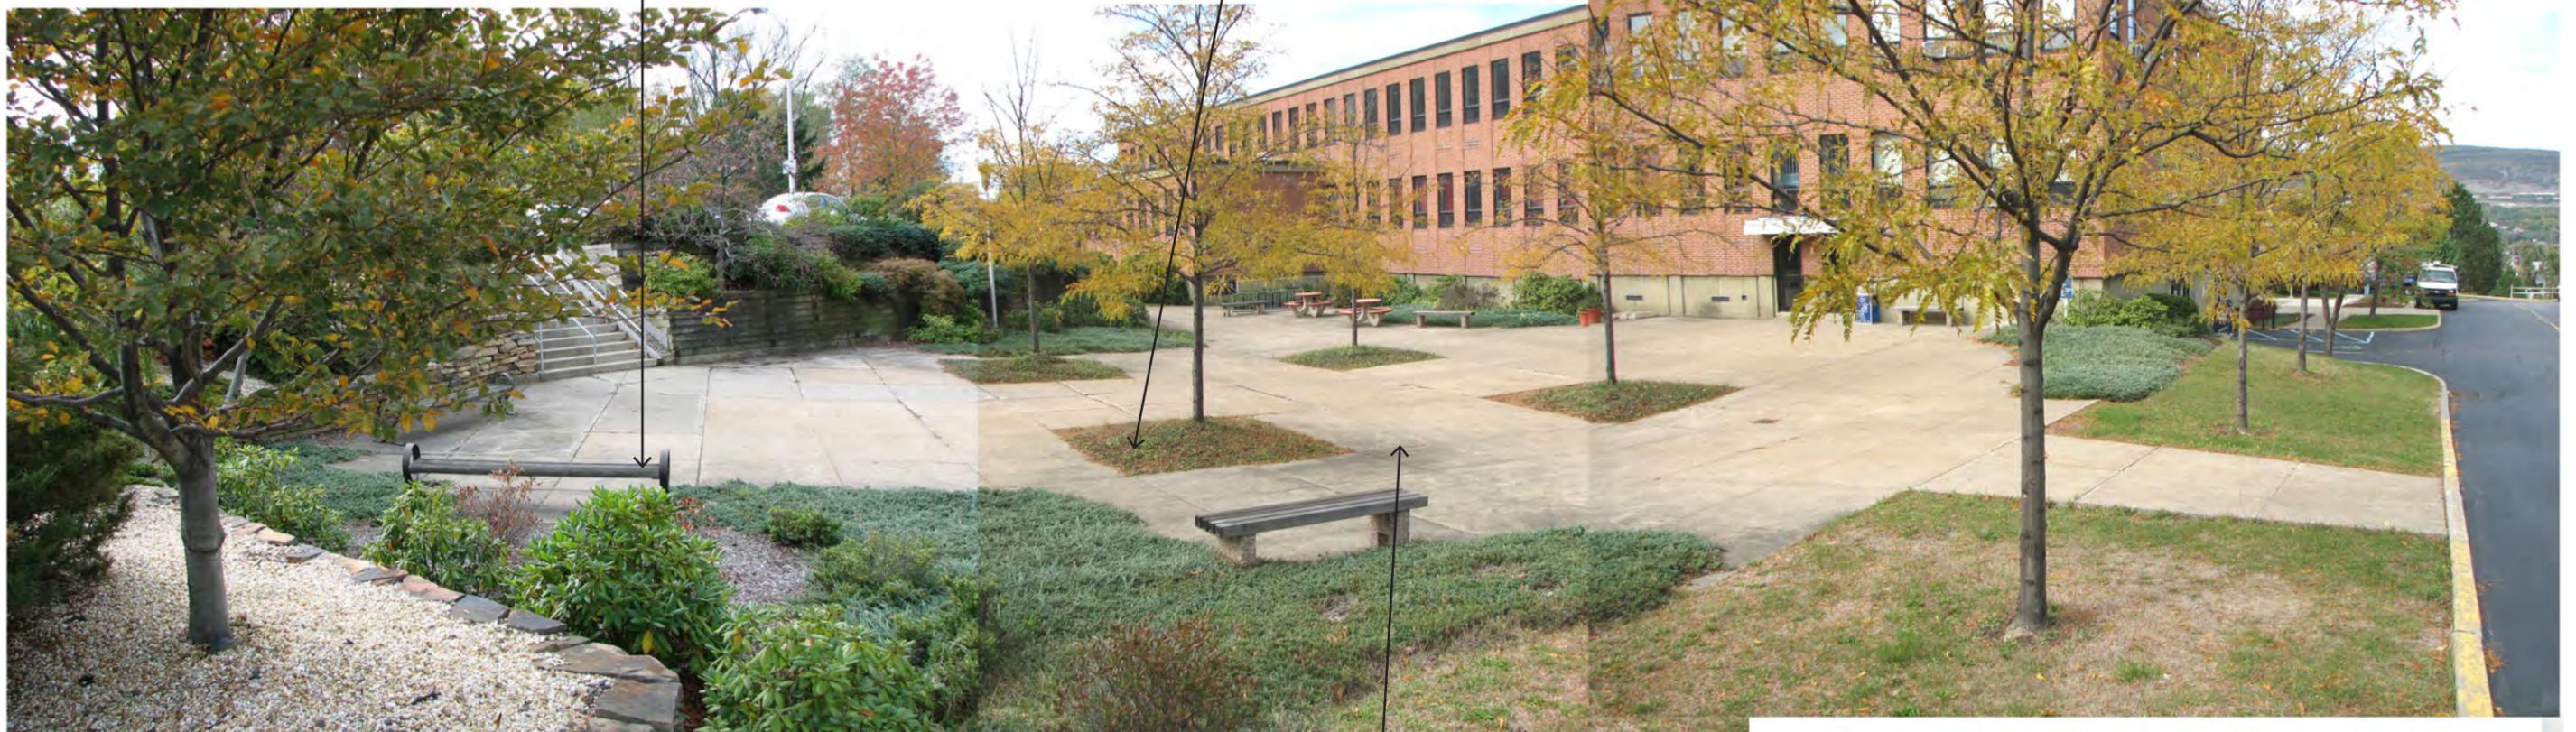
The commons area between the Study Learning Center and Dawson Building is characterized by excessive concrete pavement. A more hospitable pedestrian quality can be

achieved by removing under utilized paved areas and replacing with landscaping and new site furnishings. Existing pedestrian circulation patterns are maintained.

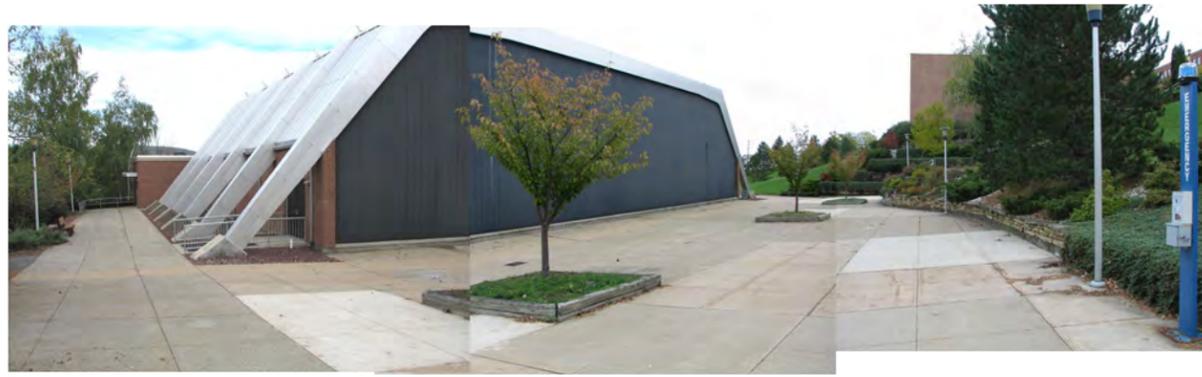
Before

Campus pedestrian walkways are oversized in some instances. Excess pavement requires more maintenance, increases water run-off and is aesthetically unattractive. It is recommended that primary pedestrian thoroughfares not exceed 10' in width. For secondary pedestrian routes the width should not exceed 6'.

It is also recommended that sidewalks be constructed using concrete as opposed to asphalt or other surfacing material. Exceptions to this rule include special enhanced plazas such as the lion monument and proposed enhancements to Dawson Building Commons.

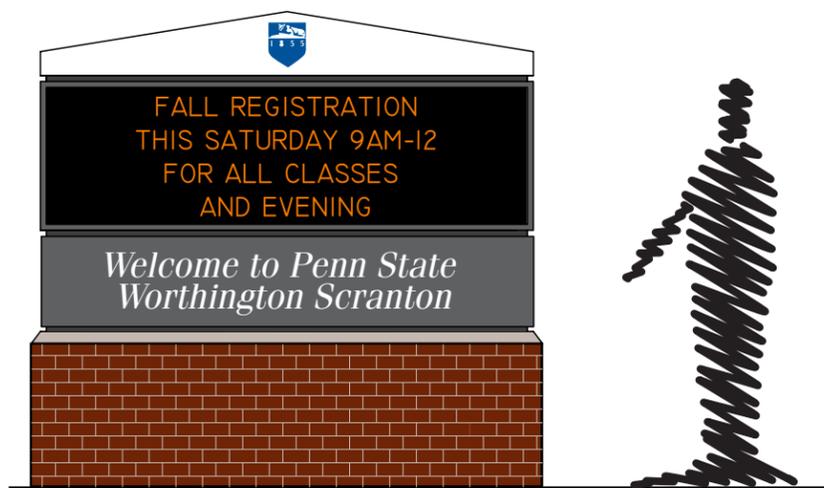
New Event Sign

A monumental campus entrance marker is recommended for the corner of the campus along University Drive to be supplemented at the new driveway entrance by the changeable message board event sign.

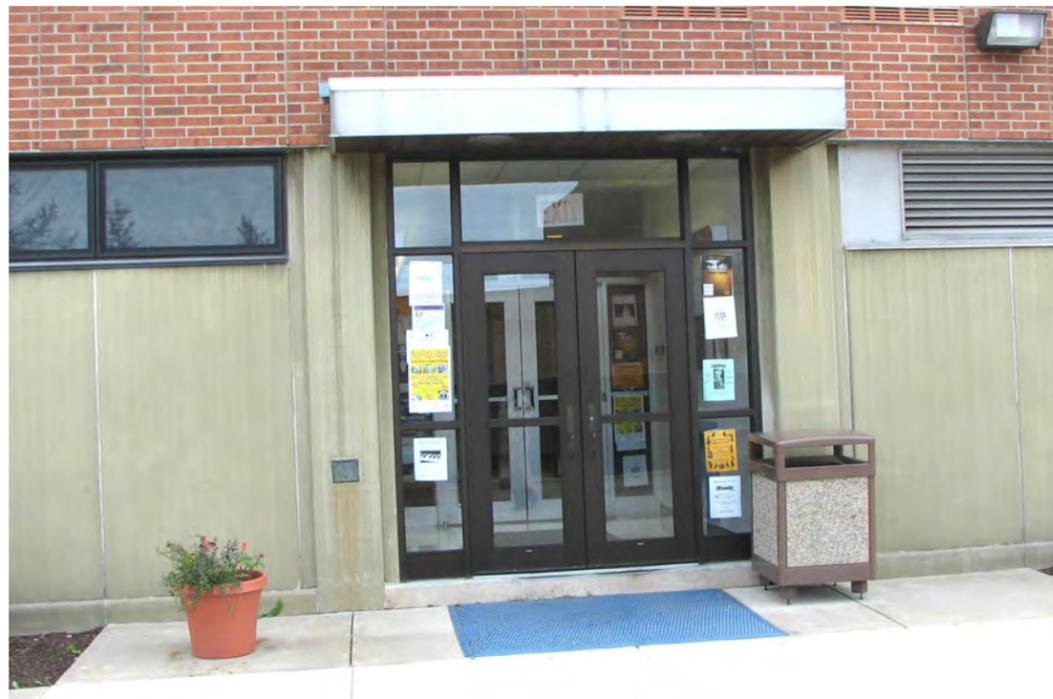
Before

Building entrance vestibules and windows are often cluttered by postings advertising a variety of announcements and events. A centralized location for this necessary function should be identified and enforced.
