Penn State
Harrisburg
The Capital College

Campus Exterior Architectural Plan
November 2006

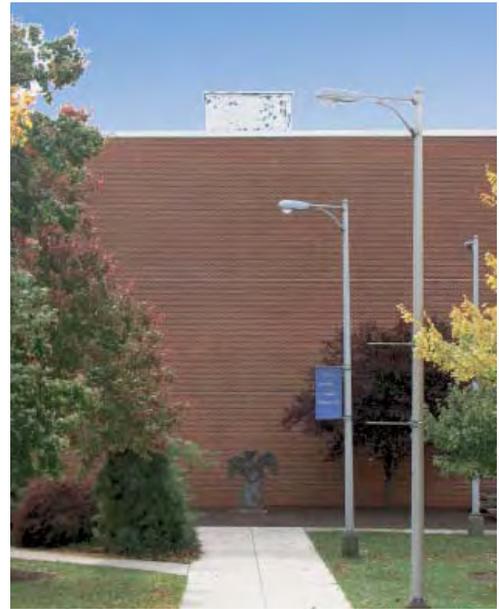
1D Church/Wrisberg/Dining Halls

The landscape and buildings in this area impart a feeling of abandonment and neglect. While in transition to other uses, the landscape surrounding these buildings requires routine maintenance such as weed control, pruning and mulching. Glass in the door to the dining hall is broken. Stored materials inside are visible from the exterior. Dining Hall signage on the building should be removed. Railings and fire escape stair towers require painting.

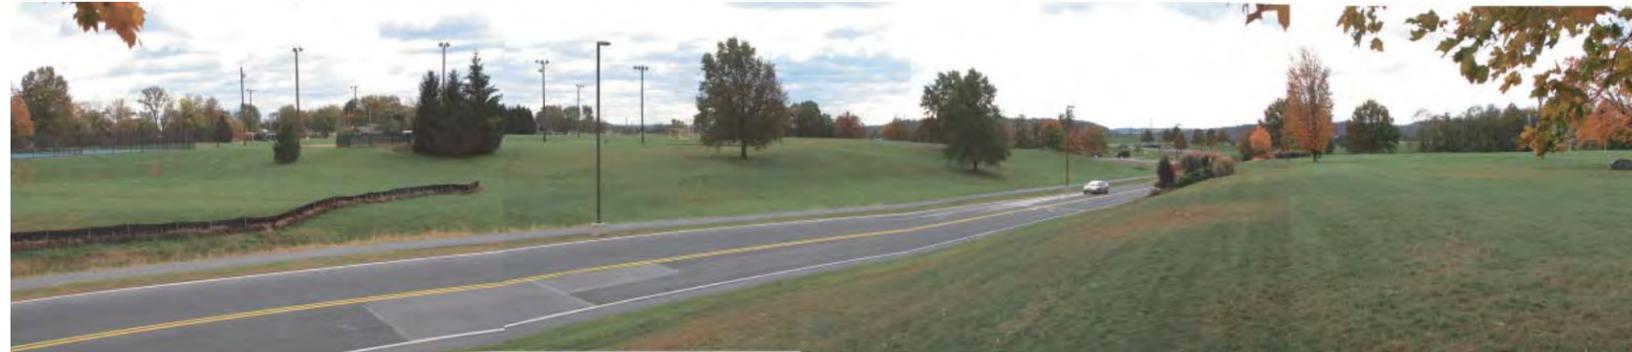
1 - Looking south along College Avenue

The landscape of the main entrance to campus is characterized by moderately sloping grassy terrain dotted with mature trees flanking the gently curving roadway. The park-like nature of the entry experience can be enhanced by supplemental tree plantings (evergreen and deciduous). The hillside west of the entrance facing Rt. 230 is presently devoid of trees. Significant tree plantings on this slope will add interest and screen the Engineering Laboratory Building.

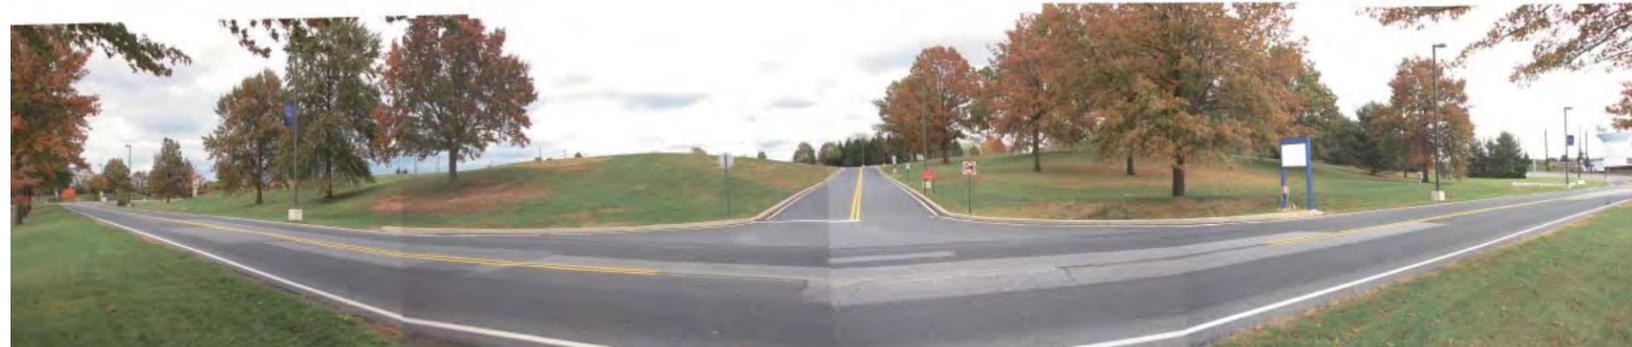
2 - Panorama at Olmsted Drive/College Avenue intersection

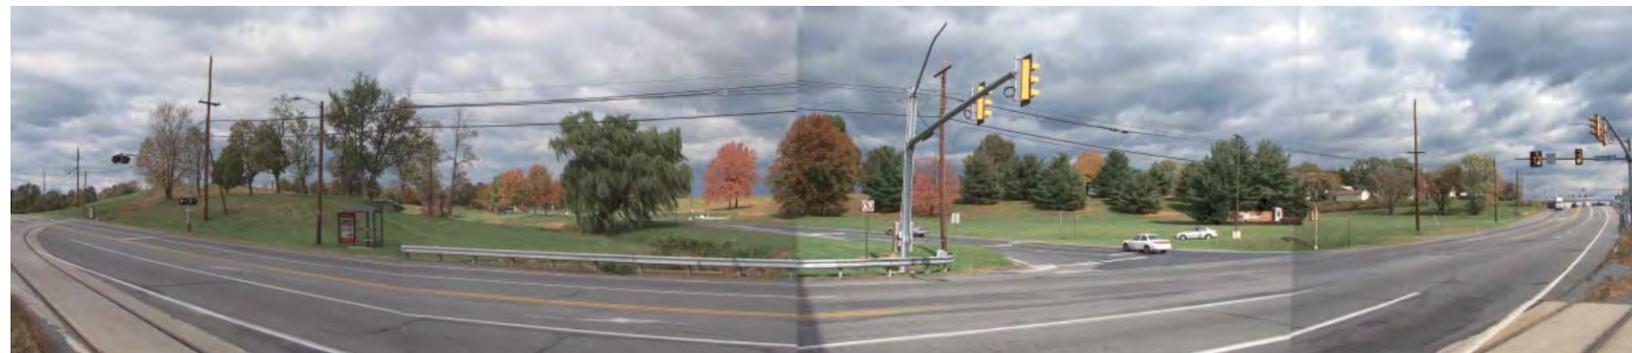
3 - Panorama at Rt. 230/College Avenue intersection

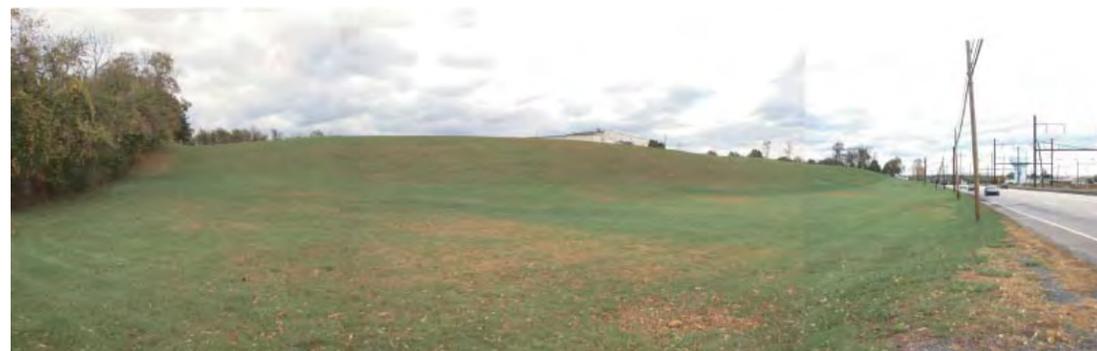
4 - Looking east along Rt 230 from property corner

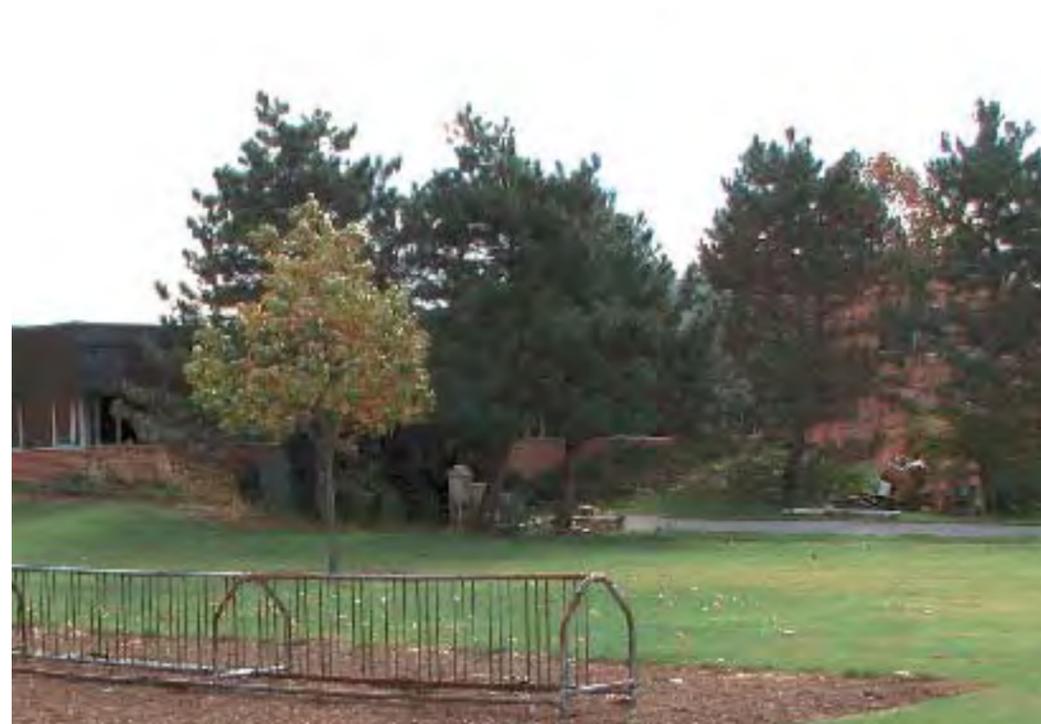
1 - Loading area

The view of the Science and Technology Center from College Avenue can be enhanced by screening and/or removing stored materials from the loading area.

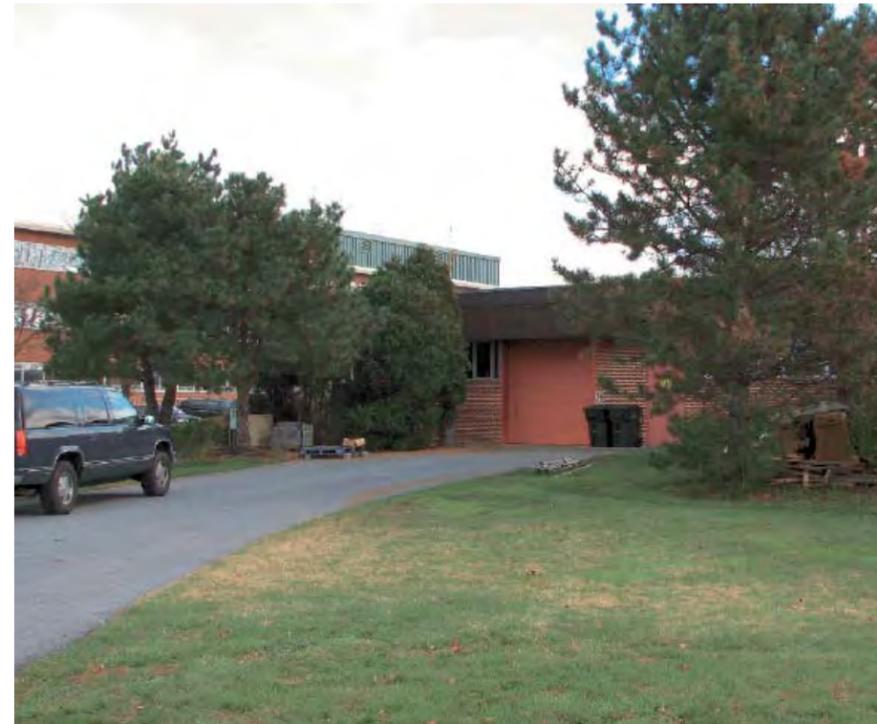
2 - Loading area

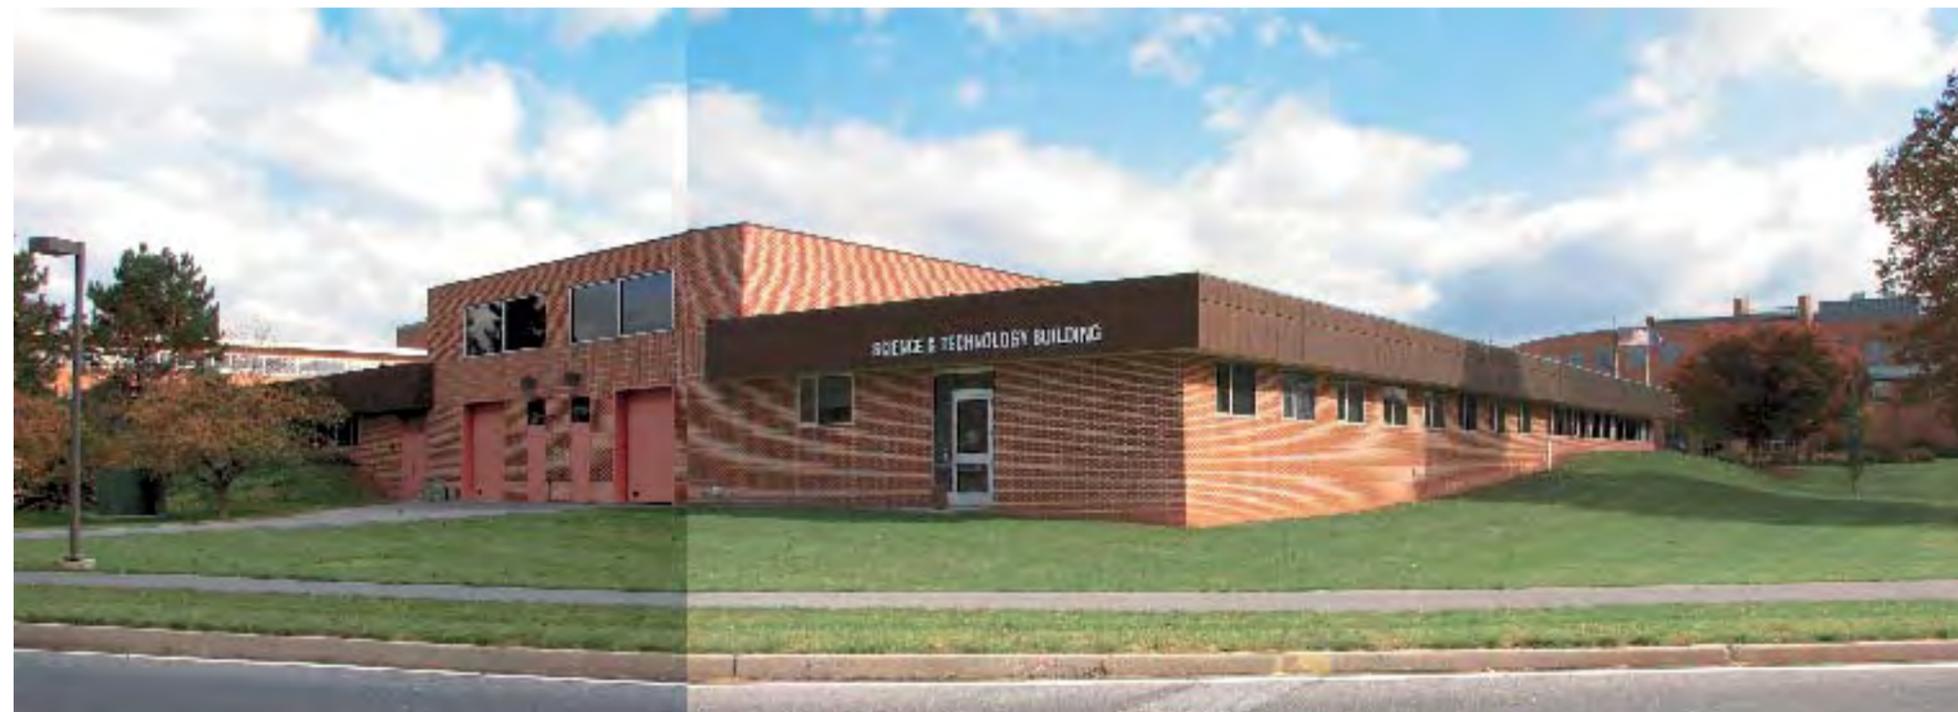
3 - Southeast building corner

Install new landscape plantings to soften and accent the southeast corner of the building.

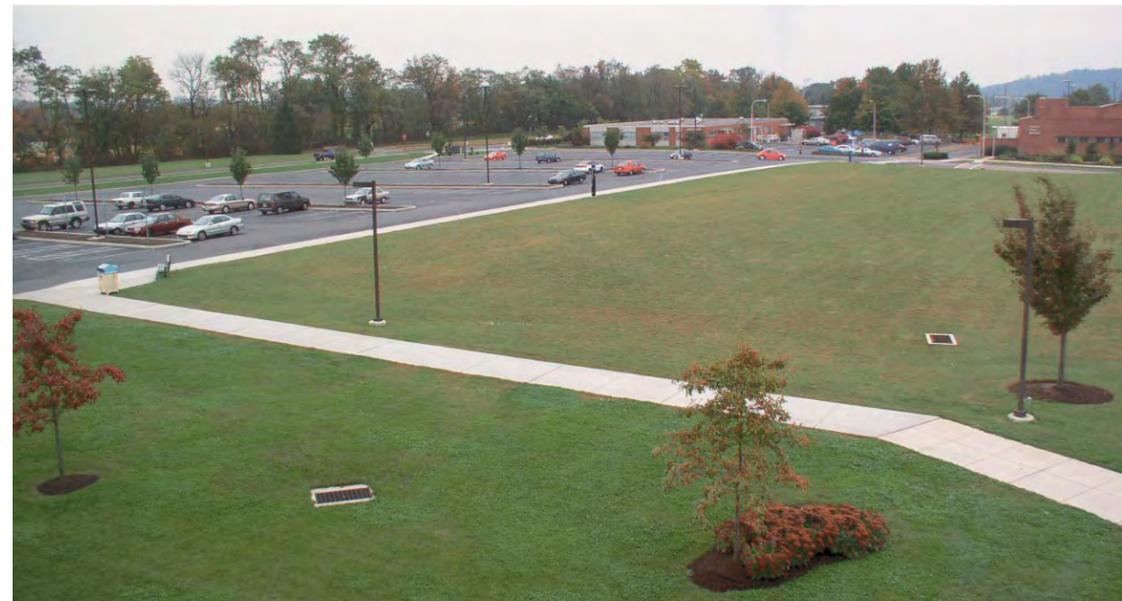
The walkway between the Library and the CUB is heavily traveled. Landscaping and site furnishings along this important pedestrian circulation route is recommended.

2 - Walkway from Library to CUB

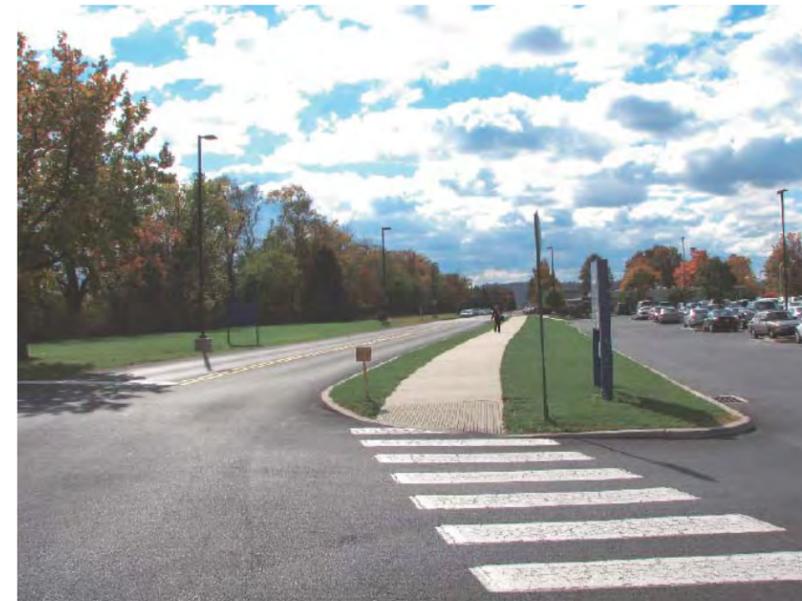
3 - Walkway from Library to CUB

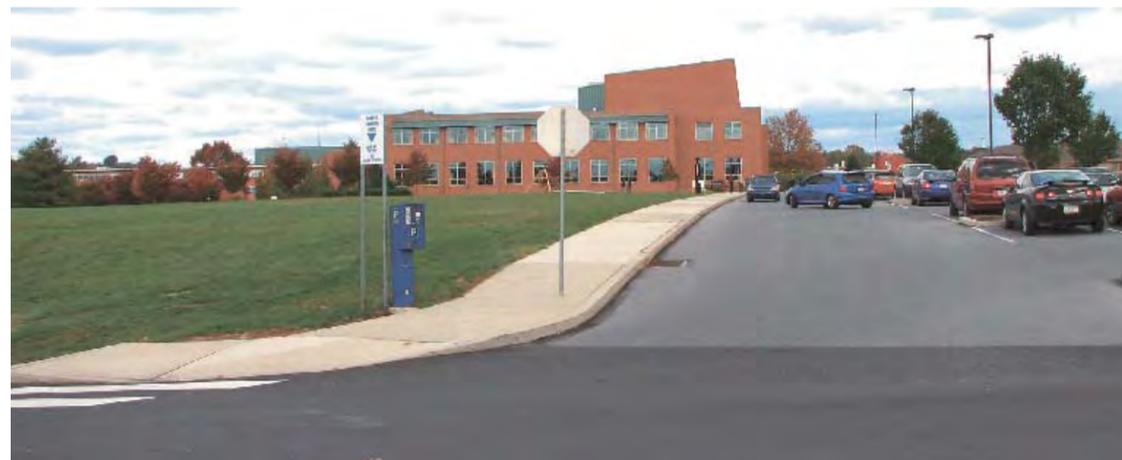
4 - Walkway from Library to CUB

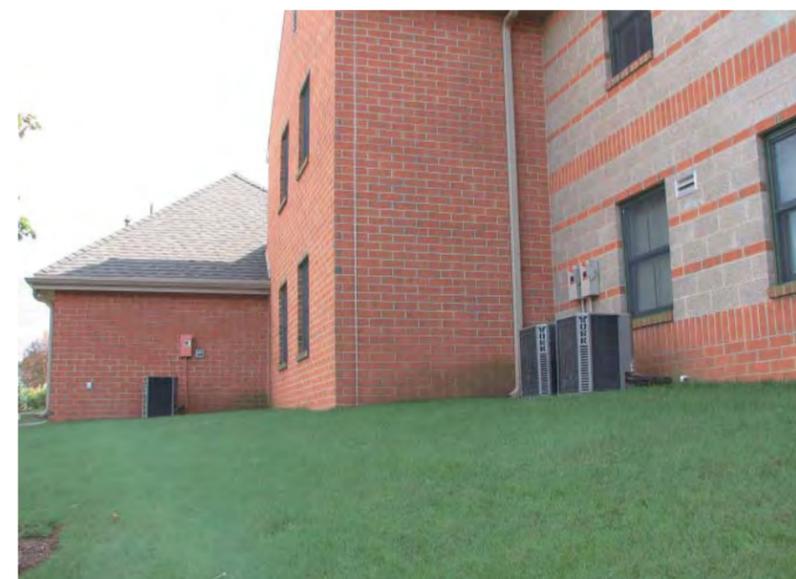
Landscape plantings in and around the student housing village is sparse. Various mechanical equipment is not appropriately screened from view. Turf areas within quads are worn.

Typical View of Mechanical and Electrical Equipment
