Penn State DU1001S

Campus Exterior Architectural Plan
October 2009

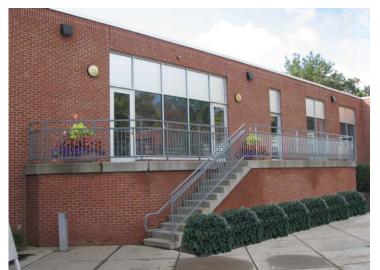
1_B

The opportunity for day to day informal use of the terrace outside of the DEF Building is missed because it is unfurnished.

Recommend the placement of movable cafe tables and chairs that can serve the breakout function from the conference room as well as the potential daily informal user.

The inclusion of planters on the patio will enhance the comfort of the space as well.

Consider sidewalk adjustments to accommodate foundation planting at base of patio or place planters to soften the hard edges of wall and walk.

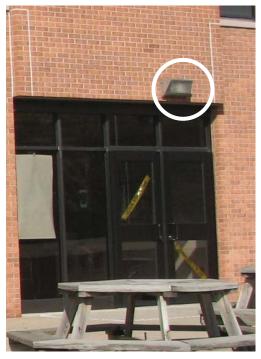
Wall pack fixtures should be avoided at building entrances

Replacement of any antiquated, inefficient pedestrian walkway and parking lot lighting is recommended. Metal halide lamps in cut-off luminaires mounted to poles are recommended for pedestrian walkways.

High pressure sodium lamping is acceptable for parking lot lights. Color/finish for all fixtures should be consistent campus wide.

Avoid the use of bollards due to vulnerability to snow removal operations and vandalism. It is also recommended that wall mounted "utility style" fixtures be avoided.

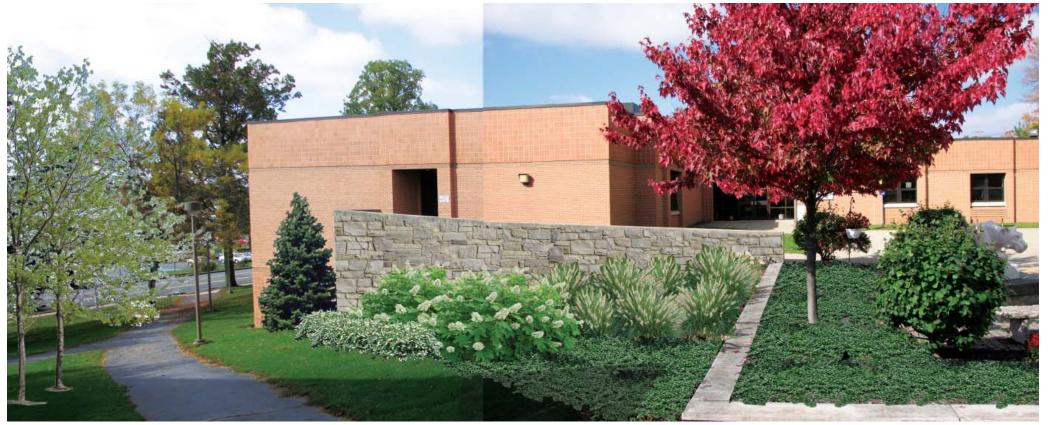
Existing rail in disrepair. Widening and planting a barrier will allow for removal.

Recommend that the paved area be reduced and supplemented with permanent landscape plantings at the entrance. By reducing the width of the paving and installing the vegetated barrier the railing can be eliminated.

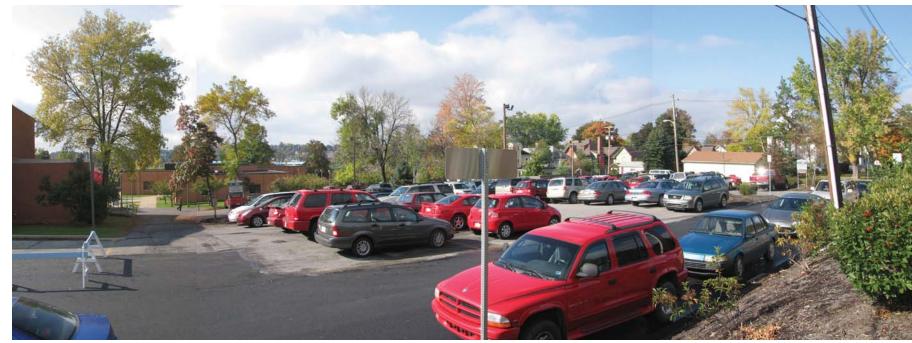
The existing parking lot west of the Multi-Purpose Building is inefficient and inadequately screened.

This recommendation calls for the realignment of parking stalls, aisles and lot entrances. New parking lot lighting should be installed.

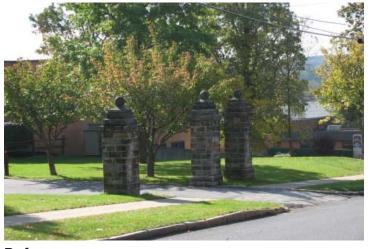
This architectural remnant from the previous land use has been appropriately preserved.

Recommend that this entrance be restricted to pedestrians only. Place new curb along College Place and pave the threshold with an enhanced material to distinguish it. Plant ornamental shrubs and groundcover to further define the entrance.

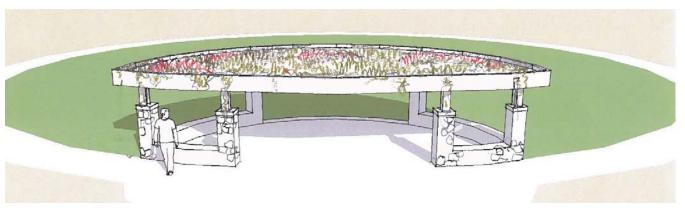
This existing wooden gazebo in the landscape is in disrepair. It's character is too rustic for a university campus.

The shelter function of the wooden pavilion could be replaced by a new structure. This concept shows a green roof in keeping with Penn State's commitment to sustainable design practices.

Custom pavilion structure with green roof

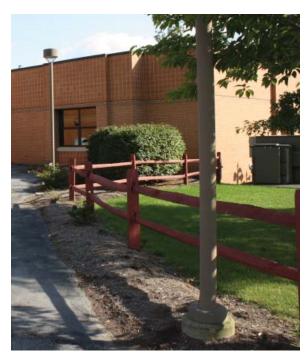
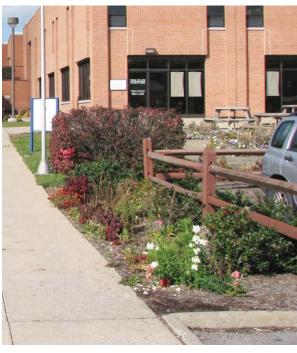
The visual character of split rail fence is not consistent with a college campus. In cases where a physical barrier is necessary it is recommended that a metal post and chain be used.

Recommended post and chain barrier where necessary
